# **MINE CLOSURE PLAN**

## **CARINA OPERATIONS REV 1.0**

**30 APRIL 2024 VERSION 0**

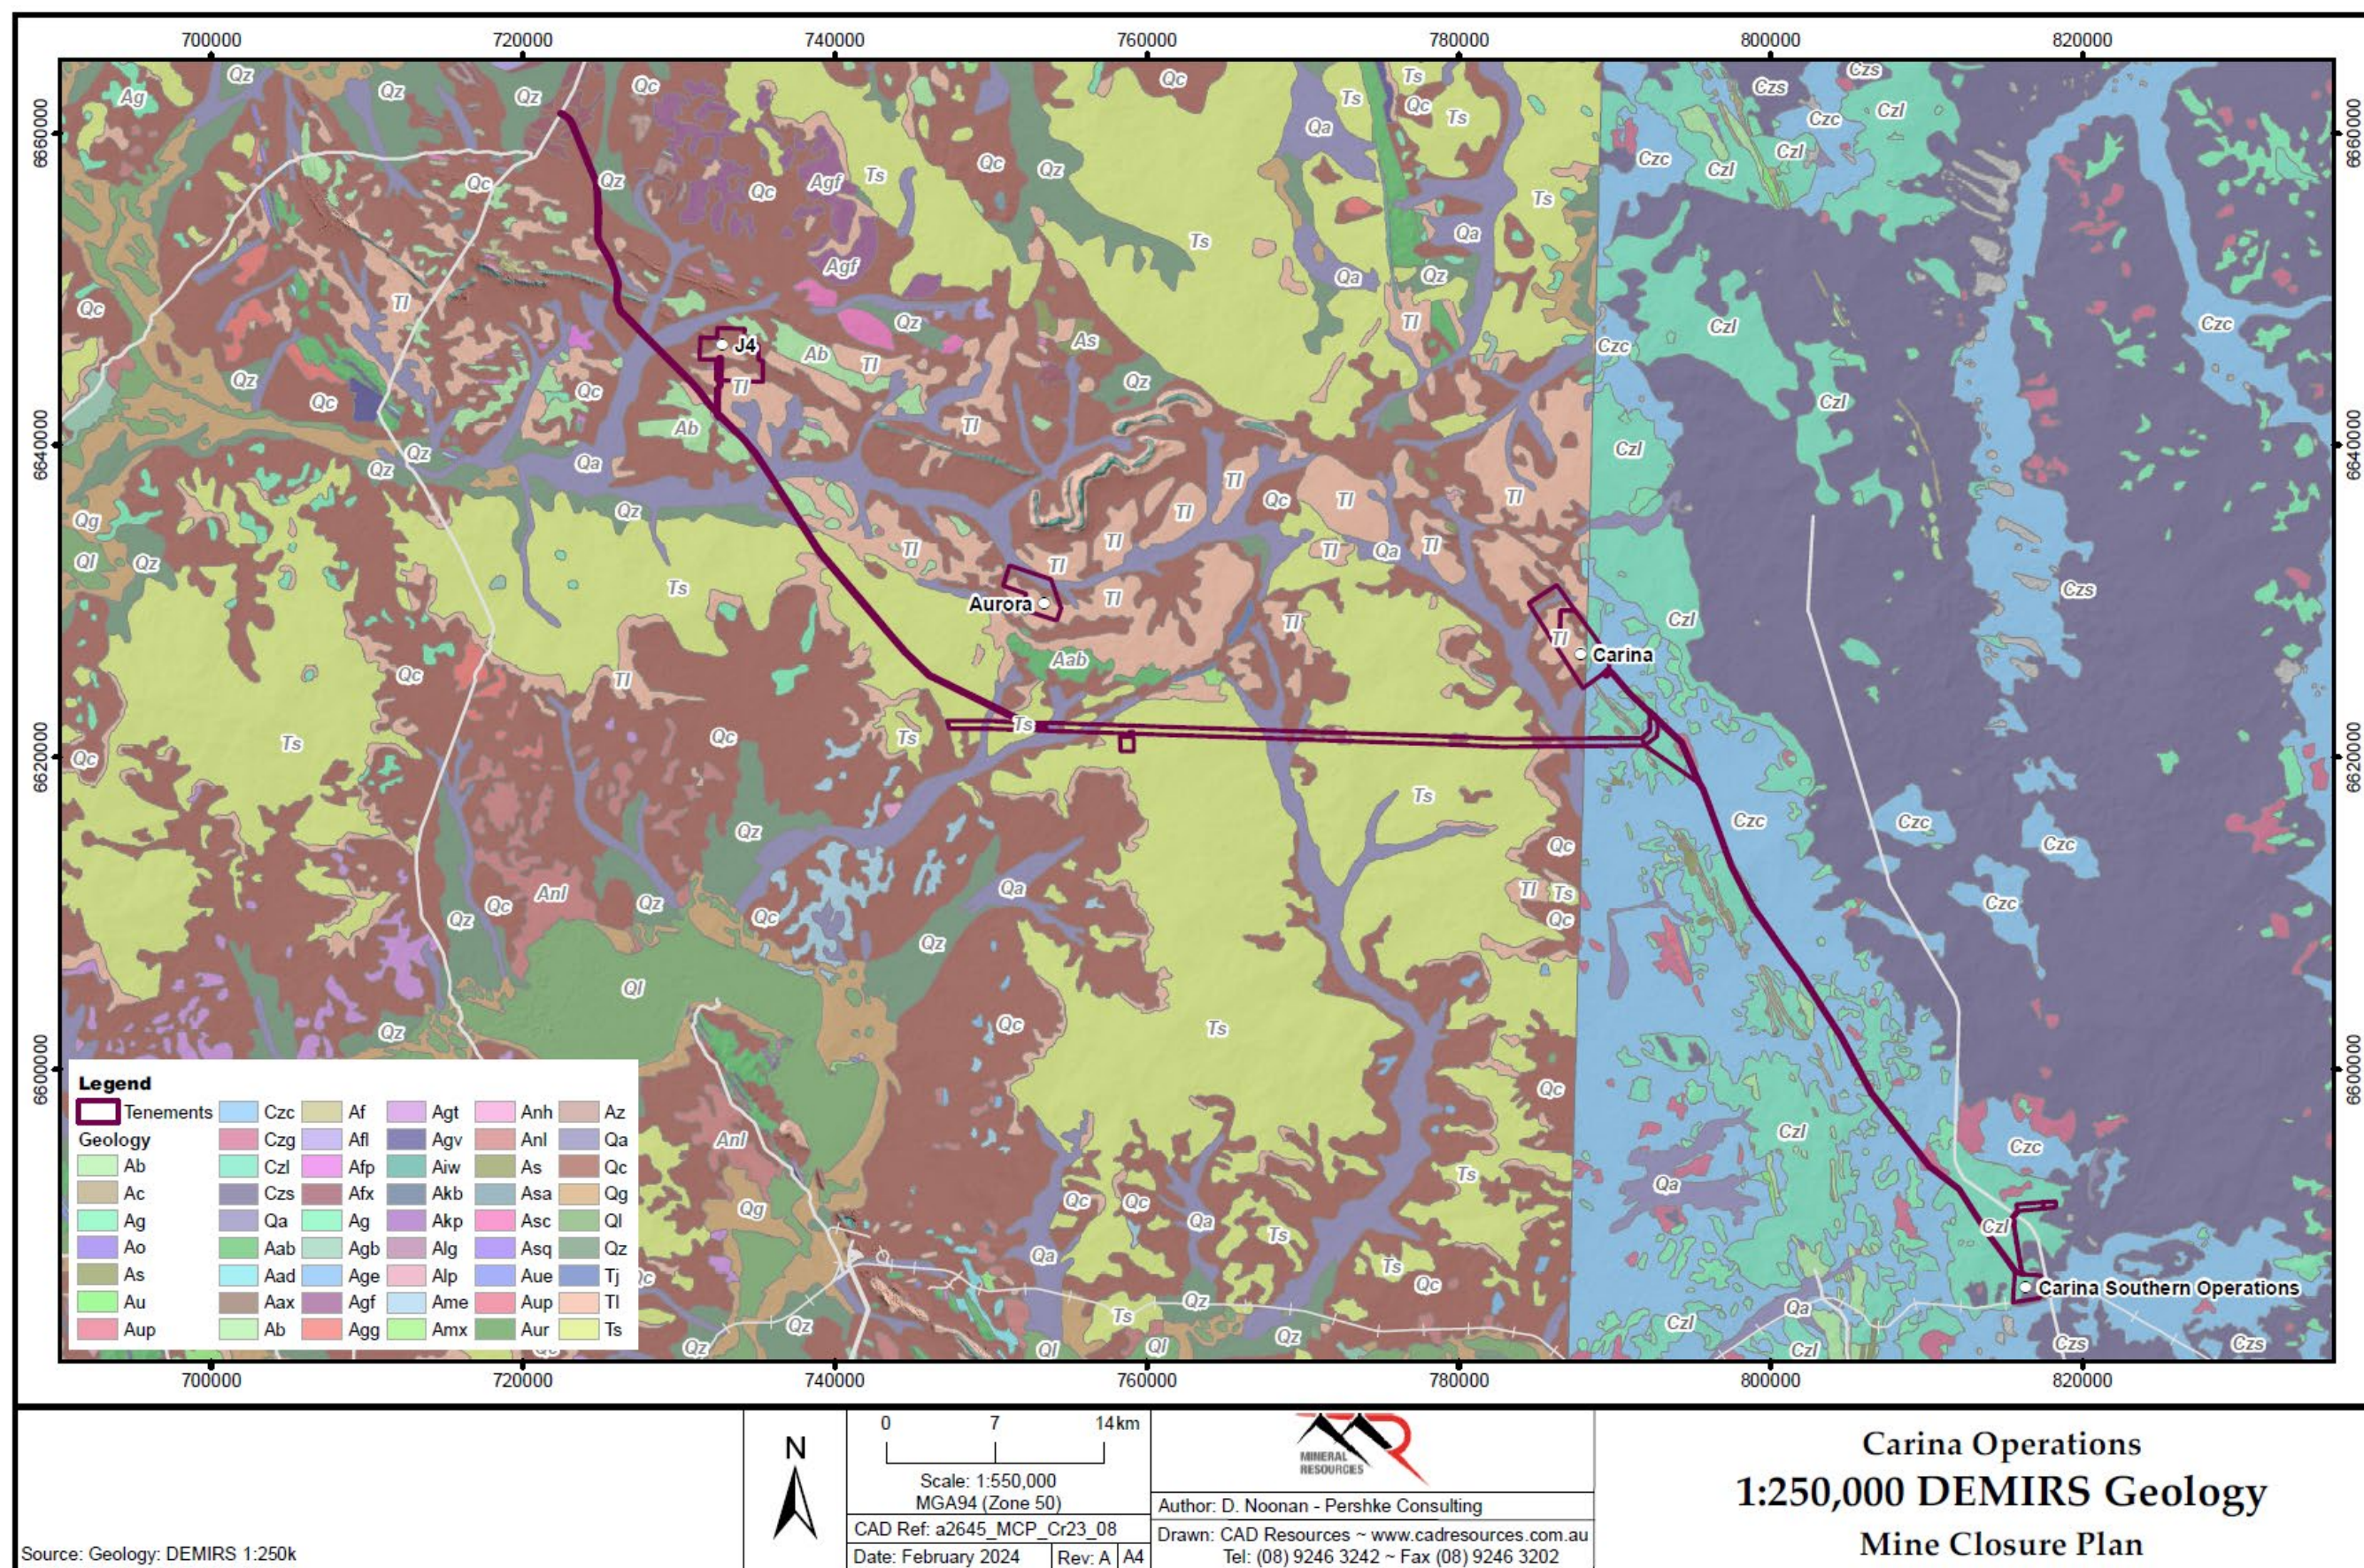
Figure 18 Carina Operations Geology

The Aurora tenement forms part of an easterly trending sequence of mafic volcanics (Figure 21). The gold mineralisation was hosted by northerly dipping quartz veins in those mafic volcanics. The gold was supergene enriched in ferruginous clays and had also spread into the laterite capping (Willmine Pty Ltd, 1994).

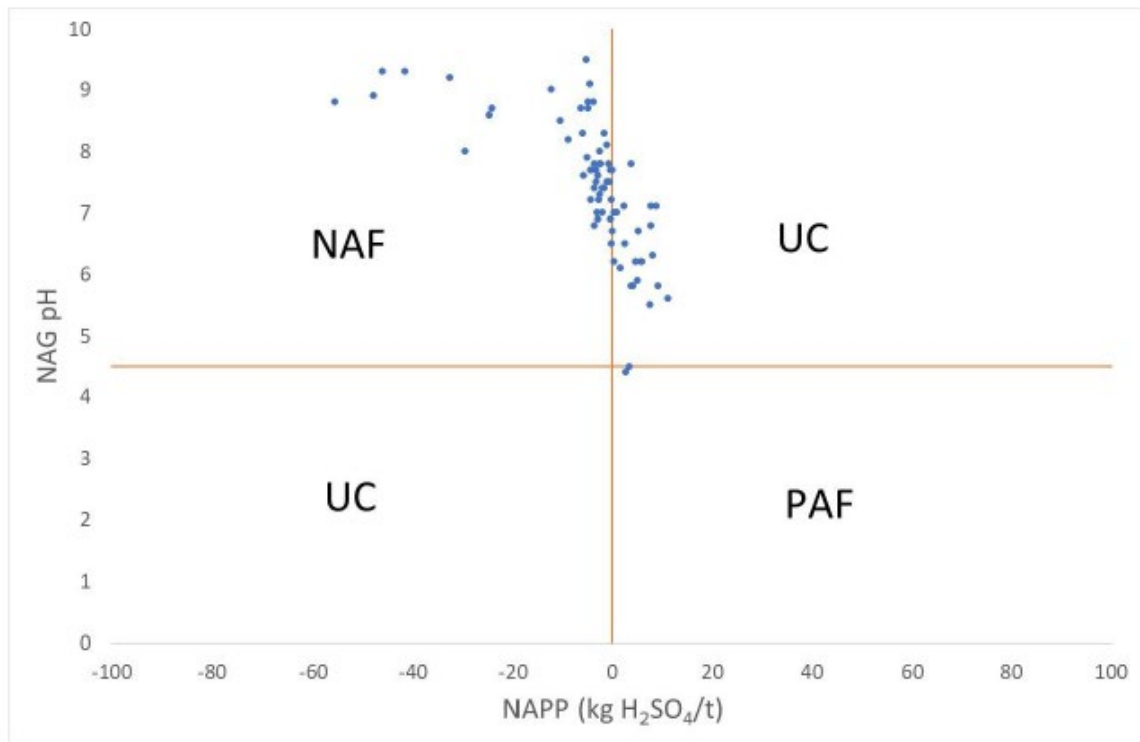
Figure 24 J4 East and J4 West PAF / NAF Classification according to AMIRA (2002) (MinRes, 2024)

Ten locations, also predominantly on the southern end of the J4 East WRL, were found to be highly saline, with three locations exceeding 400 mS/m, the threshold that will likely impact on even extremely salt tolerant species. One third of samples exceeded the salinity threshold of 200 mS/m cited by

Landloch (2023). The median EC for the J4 East WRL samples was 160 mS/m. Three sites on the J4 West WRL, on the western end of the upper lift, also tested as highly saline. The median EC for the J4 West WRL was 74 mS/m. These results differ from the Mine Earth (2022) results (noting that the latter were for surface samples only) (Section 5.3.5.1.3) which recorded only low to moderate salinity (MinRes, 2024). A preliminary desktop assessment of the potential implications of salinity for revegetation success has been completed with the results presented in Section 5.9.5.2.

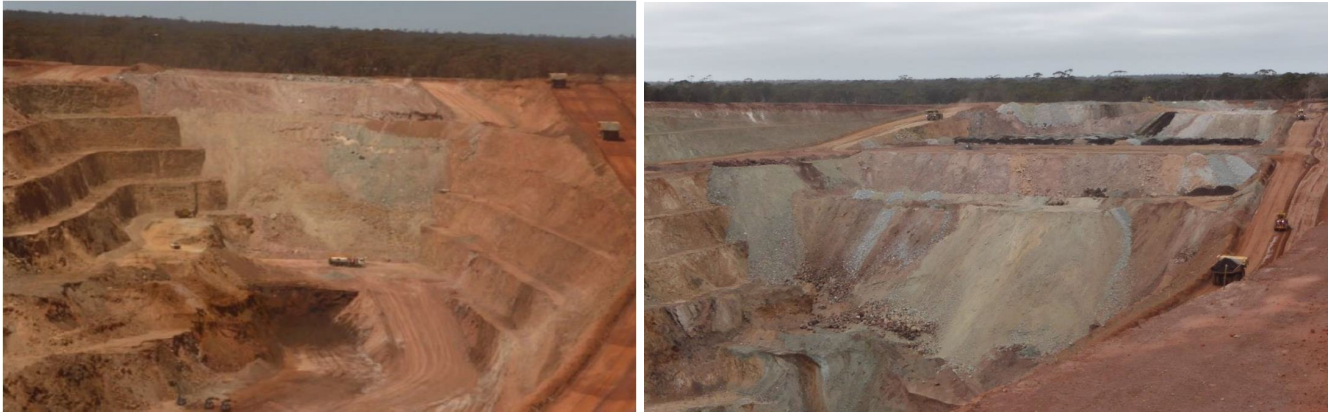
Figure 27 Carina Pit Backfill 2014 and 2015 (Okane Consultants, 2022c)

Based on this review, the Carina Pit contains approximately 1.5 Mm<sup>3</sup> of backfill material that could have been placed from September 2014 onwards. The backfill construction sequence is relatively unknown beyond a small indicated PAF survey of approximately a few thousand cubic metres. It is anticipated that PAF material not contained within the Carina WRL encapsulation cell, which contains less PAF than was planned, (refer Section 5.9.3.4) is contained within the Carina Pit backfill (Okane Consultants, 2022c).

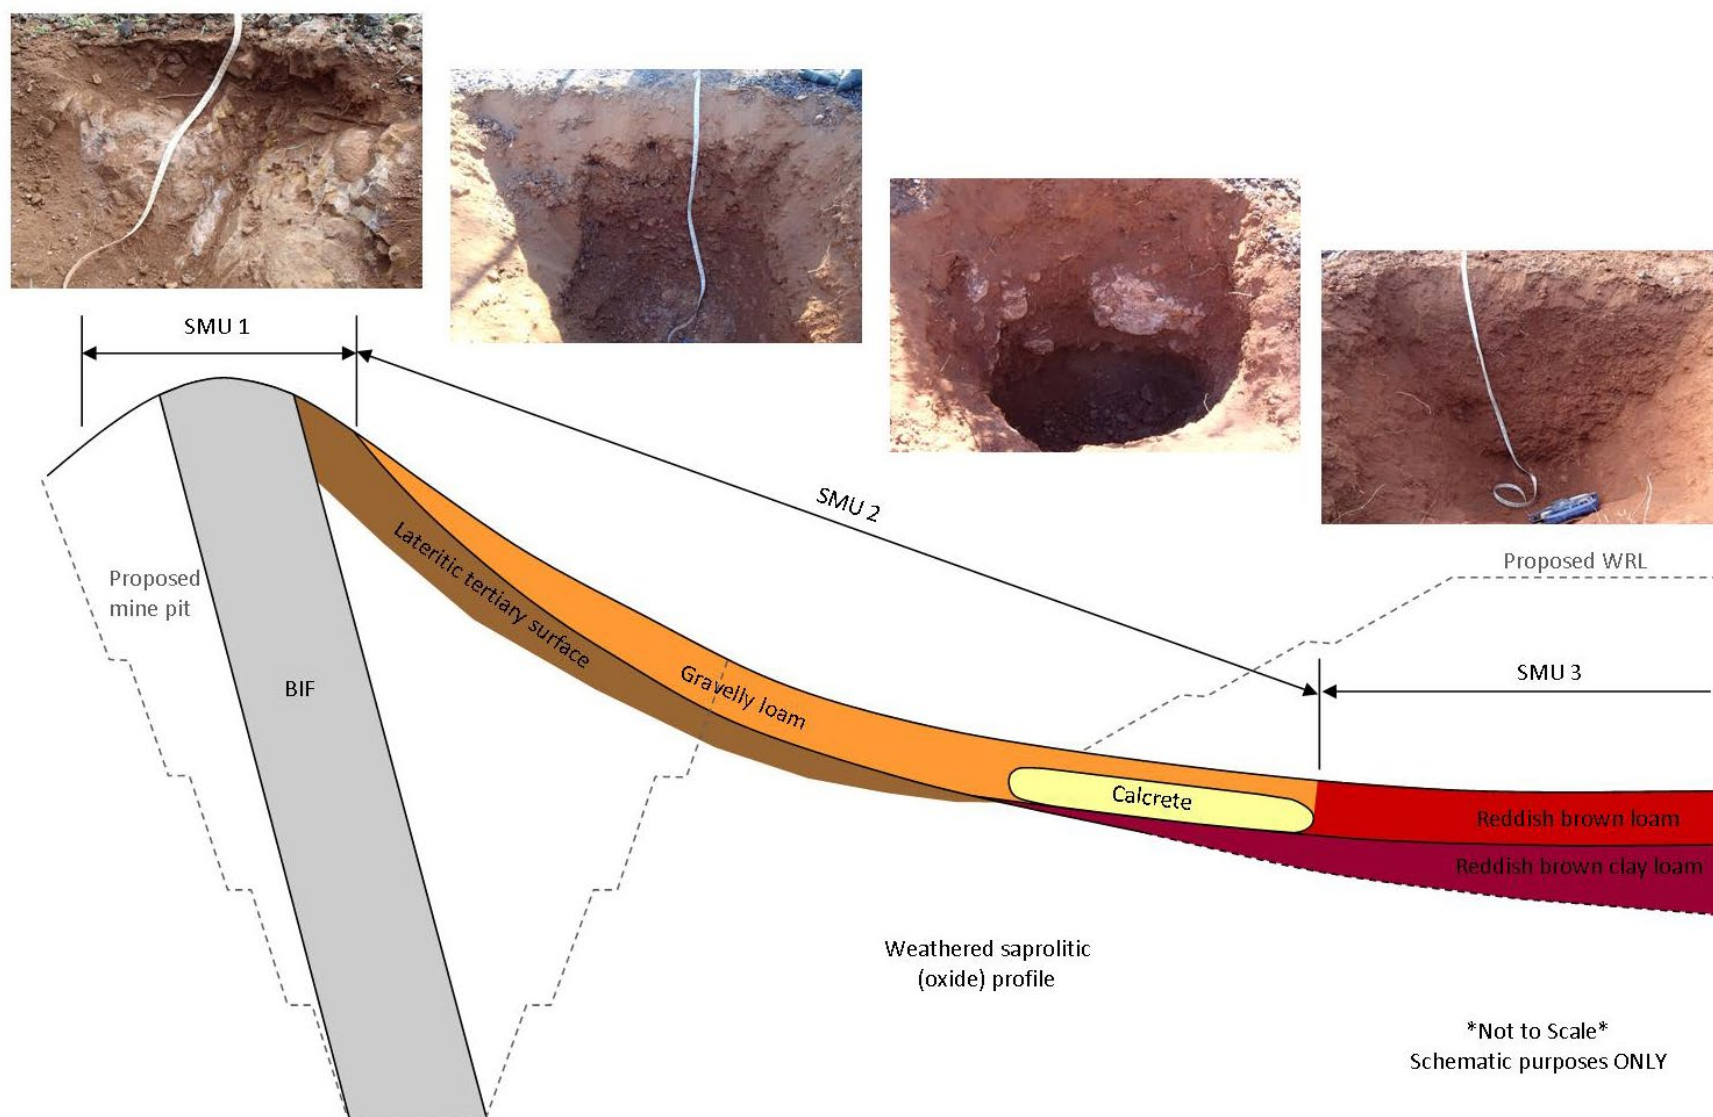
Figure 30 Schematic showing topographic sequence of soils at J4 (SWC, 2014b)

| Material | Major Soil Group of WA | Australian Soil Classification | Description |
|---|---|---|---|
| SMU 2 – Shallow-Deep Gravels | Stony soil | Lithosolic Clastic Rudosol – Leptic Rudosol | <p>The shallow – deep gravels (SMU 2) were characterised as follows (SWC, 2014b):</p> <ul style="list-style-type: none"> <li>Representative of a depositional sequence, rather than a pedogenic profile. The surface gravel generally gets finer and more rounded with increasing distance downslope, and exists in a friable brown loamy matrix, with negligible pedogenic horizonation. The contact between the surficial gravels and the underlying Tertiary surface is abrupt. There is no topsoil development within SMU 2.</li> <li>Gravel content varies between 24 – 69%, (average 42%), which is similar to SMU 1. Also, similarly to SMU 1, the soil matrix in the deeper gravels is classified as a loamy sand, with an average of 81% sand and a silt + clay content of 19.1%. This similarity between SMU 1 and 2 reflects that the gravels within SMU 2 were derived from SMU 1 and were eroded and subsequently deposited downslope.</li> <li>Moderate bulk density (~1.65 g/cm<sup>3</sup>) and free draining with saturated hydraulic conductivity values in the order of 0.6 – 2.6 m/day.</li> <li>As with the gravels in SMU 1, the finer matrix is macro-structurally unstable (i.e., slaking rapidly when rewet), but is considered non-dispersive with an Emerson Class of 5.</li> <li>The finer soil matrix has good water holding capacity (i.e., field capacity – 10 kPa moisture contents of 36%) and corresponding moderate to high PAW contents of between 8 – 19% (average 12.3%).</li> <li>pH is widely variable from 4.65 to 9.06 (average 6.58). pH &gt; 8 reflect the presence of calcrete (or gypsum/dolomite) in these soils, whilst acidic pH values are a result of iron ferrolysis.</li> <li>Non-saline, with average EC of 13.6 mS/m. The one elevated salinity result was considered to be an artefact of the analysis technique and not indicative of field conditions.</li> <li>N exists in the form of mobile NO<sub>3</sub>-N and has leached from the topsoils so that they are deficient in N as well as deficient in Colwell P (&lt; 5 mg/kg) but have moderate levels of Colwell K (average 135.2 mg/kg) and Extractable S (average 6.9 mg/kg).</li> <li>Very low organic C content (typically &lt; 1.0%) reflecting the lack of organic matter accumulation observed in the field.</li> <li>Generally non-sodic (ESP &lt; 6%), although there is an increase in ESP with depth (i.e., &gt; 70 cm). Low CEC values (average 9.0 meq/100g) indicated that kaolinite is the dominant clay mineral.</li> <li>No microbial properties were assessed for this soil type, although given its similarity to the skeletal SMU 1 soils and lack of both organic C and organic matter, it was considered that the gravelly soils of SMU 2 would also be biologically infertile.</li> </ul> |
| SMU 3 – Deep Alluvial Clays | Brown, non-cracking clay | Brown Dermosol | <p>The ‘alluvial – clayey soils’ (SMU 3) were characterised as follows (SWC, 2014b):</p> <ul style="list-style-type: none"> <li>A homogeneous reddish brown sandy loam, with no pedogenic horizonation or organisation, well structured, with a crumb ped morphology. Like SMU 2 no topsoil development has occurred.</li> <li>Contained less gravel (average 15%) than SMU 1 and SMU 2 soils. The gravel has a predominately pisolithic shape (i.e., small &lt; 5 mm diameter and well rounded) reflecting its transported history. The fine fraction (i.e., &lt; 2 mm) was classified as a sandy loam to clay loam, with an average of 66% sand and 34% silt + clay.</li> <li>High water holding capacity (i.e., around 40% at field capacity; 10 kPa) and PAW content (i.e., 13.2%), which are considered to be optimal soil physical properties to support plant growth. Despite the fine texture the soils have a moderate permeability (average 0.32 m/day).</li> <li>Macro-structurally unstable (i.e., slaking rapidly when rewet) and some materials have dispersive tendencies (i.e., Emerson Class 2), with the clays remaining in suspension for a prolonged period.</li> <li>pH is widely variable (pH 5.03 – 9.07). Higher pH reflects the influence of calcrete (or gypsum/dolomite) formation and lower pH may reflect ferrolysis of iron minerals.</li> <li>Non-saline with an average EC of 17.86 mS/m. Elevated EC values were considered to be due to dissolution of soluble salts during EC measurement, and not indicative of field conditions.</li> <li>Low N and Colwell P (&lt; 5 mg/kg) but contain moderate levels of Colwell K (average 135.2 mg/kg) and Extractable S (average 6.9 mg/kg).</li> <li>Very low organic C content (typically &lt; 1.0%) reflecting the lack of organic matter accumulation observed in the field.</li> <li>Sodic (average ESP of 8.7) and relatively high CEC (average 18.5 meq/100g; with a maximum of 32.3 meq/100g), indicating that reactive smectite is present in the clay mineral fraction of these materials.</li> <li>Low levels of MBC (12 to 38 mg/kg) reflecting the very poor topsoil development in these soils, and therefore lack of food source to support soil microbes.</li> </ul> |

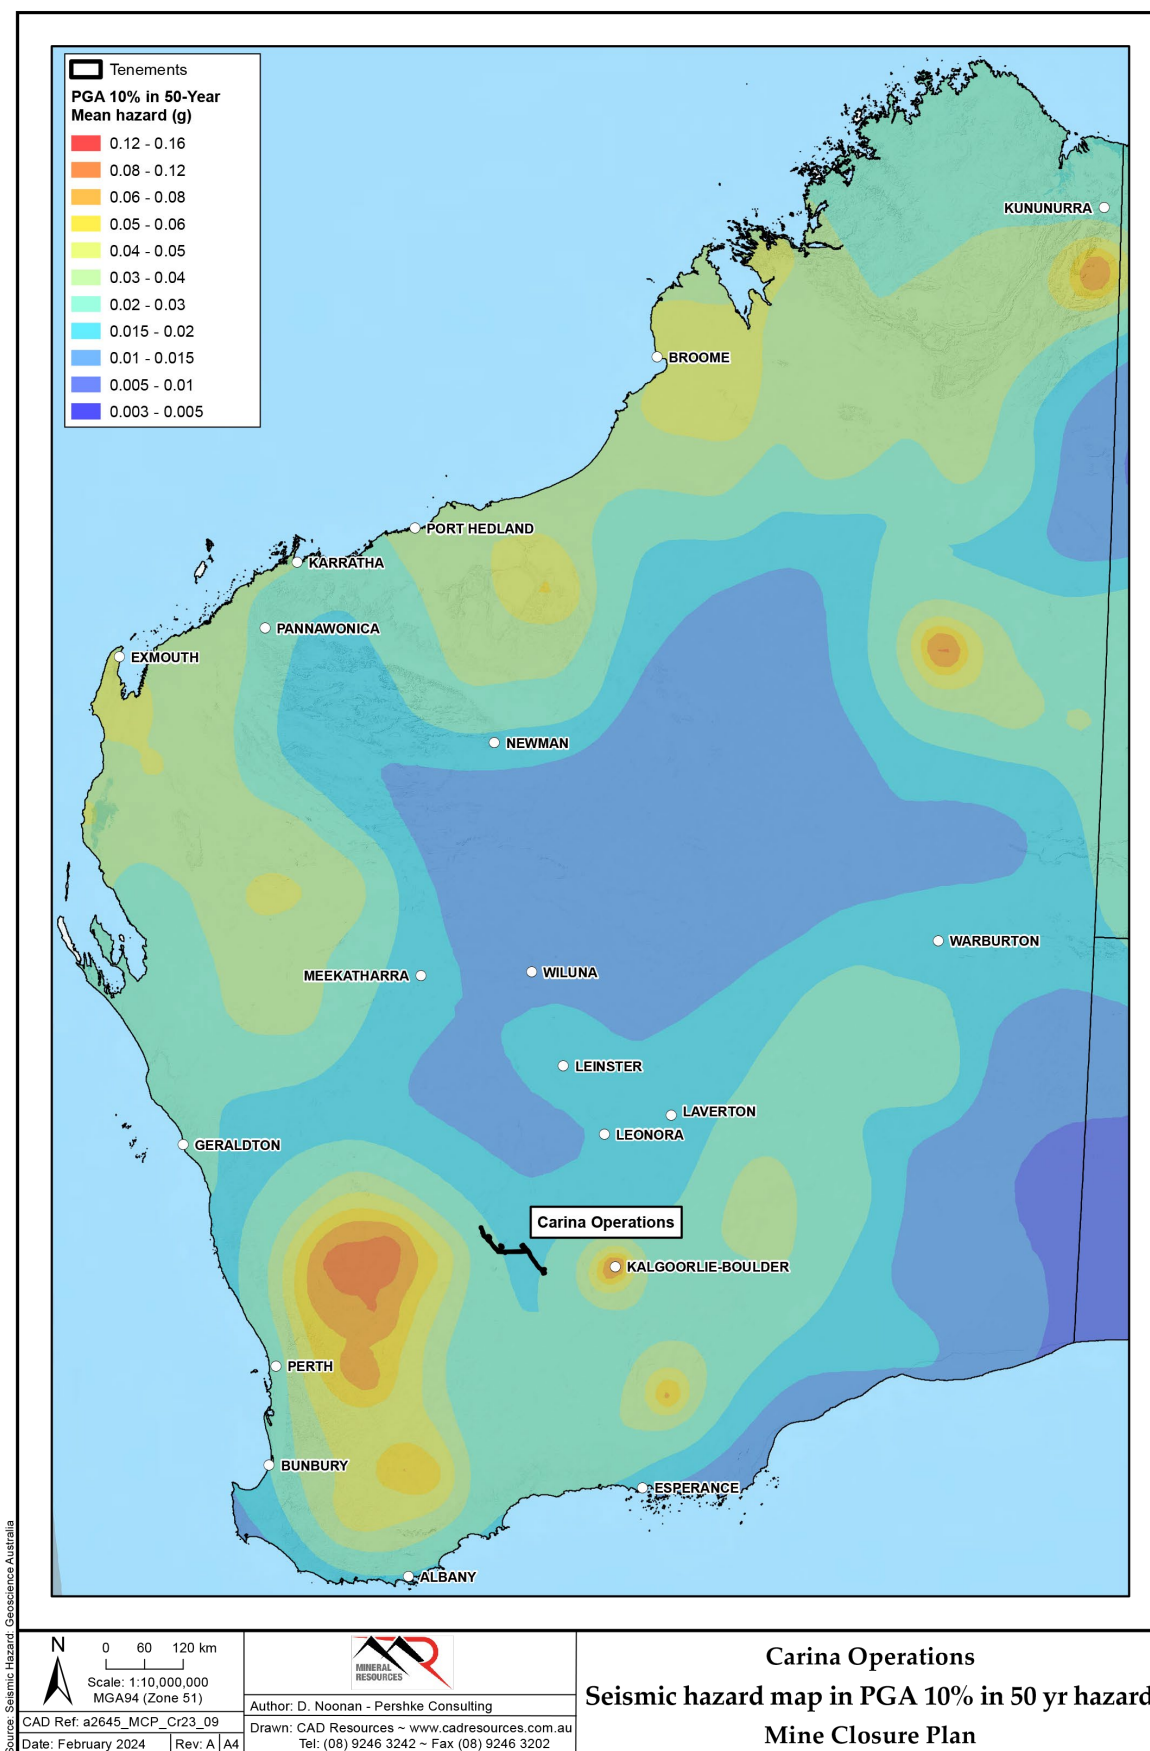
**Figure 31 Carina Operations Seismic Hazard Map**

The Carina Operations lie in a low-seismic hazard zone with a Peak Ground Acceleration (PGA) of approximately 0.015 to 0.03 g for a 10% probability of exceedance in a 50-year period (Figure 31). This equates to a 1:500 AEP.

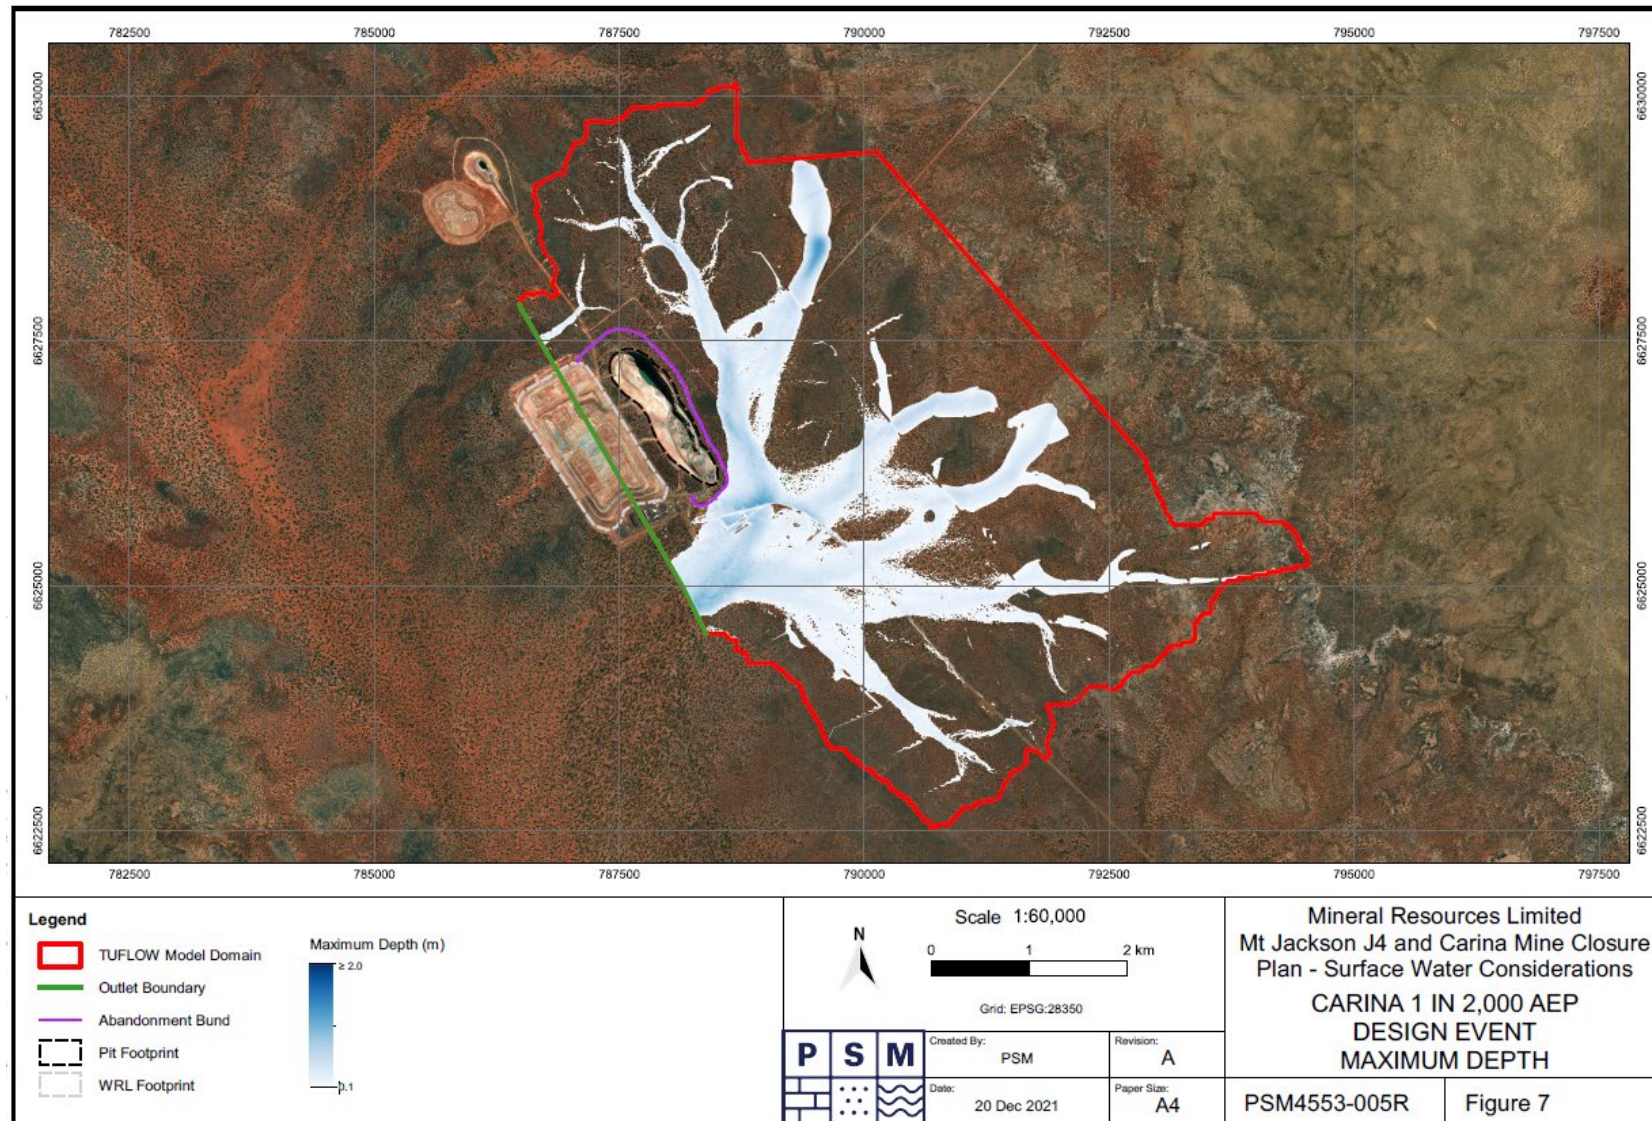
**Figure 56 Carina 1:2, 000 AEP Flood Modelling (Depth)**

PSM (2024) note that there is potential that the downstream roadway geometry was different to that modelled which could limit the validity of the flood predictions in this setting. However, including the roadway produced the maximum flood depths adjacent to the abandonment bund which is critical to establishing flood protection bund heights.

Sensitivity analysis (focussing on shorter duration events more critical to the smaller catchments) confirmed that the smaller catchments, such as those along the northern edge of the abandonment bund do not produce conditions that require additional closure measures (PSM Consult Pty Ltd, 2024).

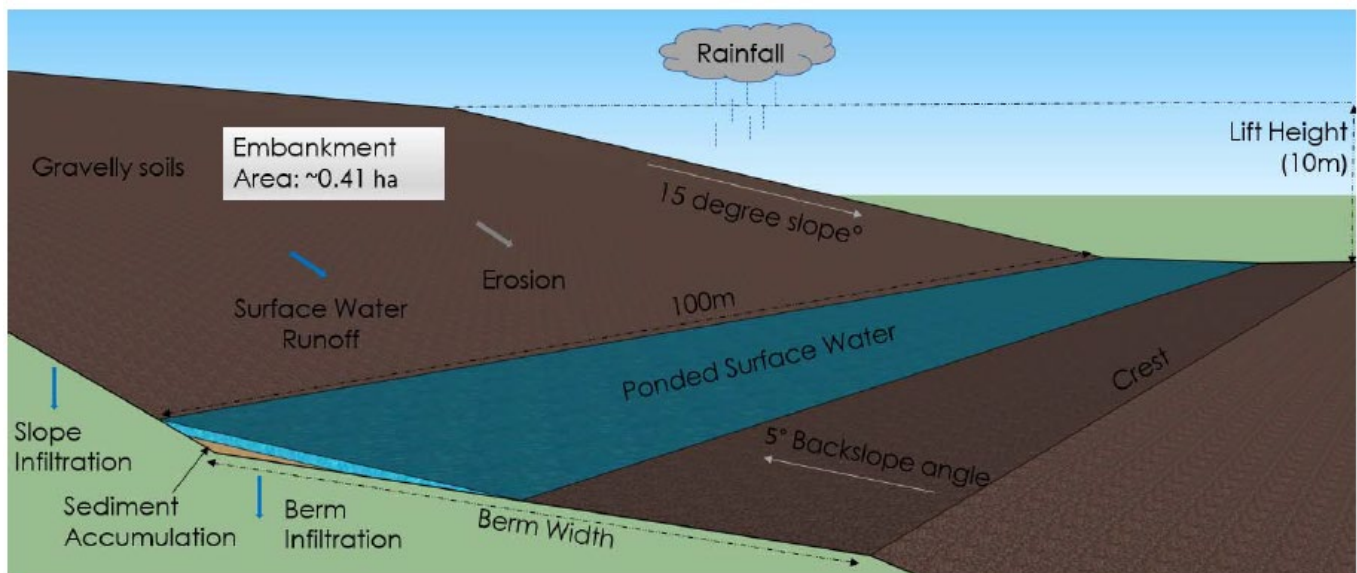
**Figure 70 Conceptualisation of the Berm Capacity Assessment**

Berm capacity modelling was initially completed to determine suitable berm widths for a range of different slope lengths at a fixed angle. This modelling involved an integrated consideration of hydrological and erosion processes for different lift heights and slope lengths, and a balance of both the sediment and water volumes to determine a minimum recommended size for the storage berms (Okane Consultants, 2022a).

The conceptual model of the system included specific rainfall and run-off conditions, the physical properties of local 'gravelly topsoils' reserved for rehabilitation activities and the embankment / berm geometry as conceptualised in Figure 70. The model assumed that there was no vegetation cover, and that crest bunds were constructed around the perimeter of the upper plateau area (Okane Consultants, 2021a).

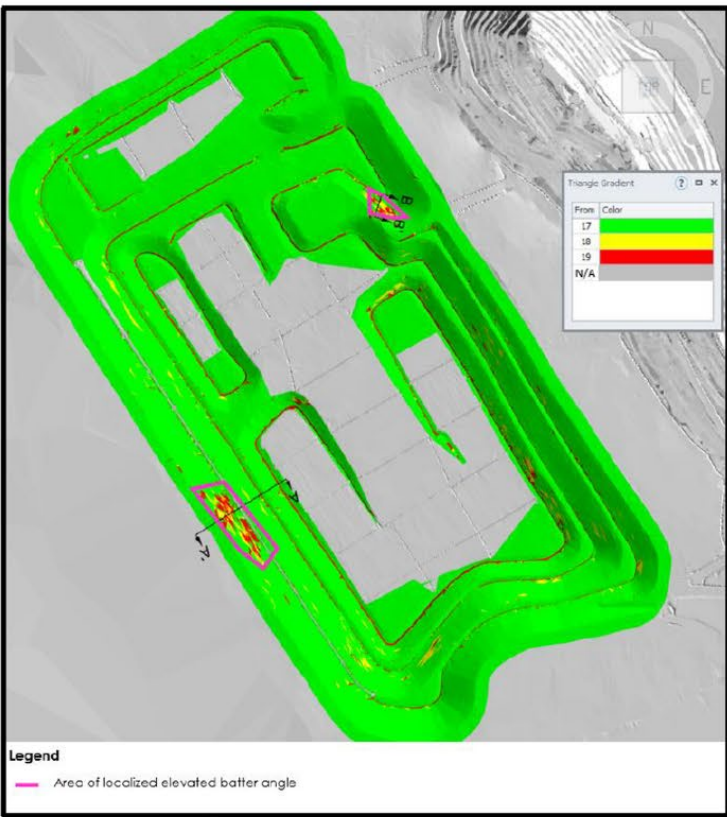
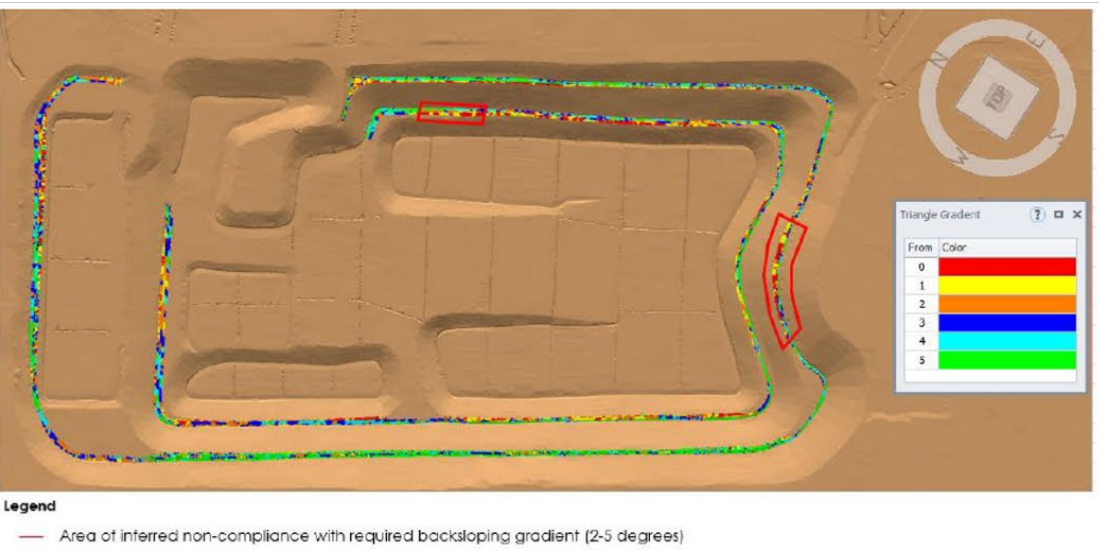
Figure 75 Carina WRL – As-Built Design Assessment

Batter Gradient Assessment

Batter Backslope Assessment

The key gaps between the design and as built geometry are (Table 46 and Figure 75) (Okane Consultants, 2022a):

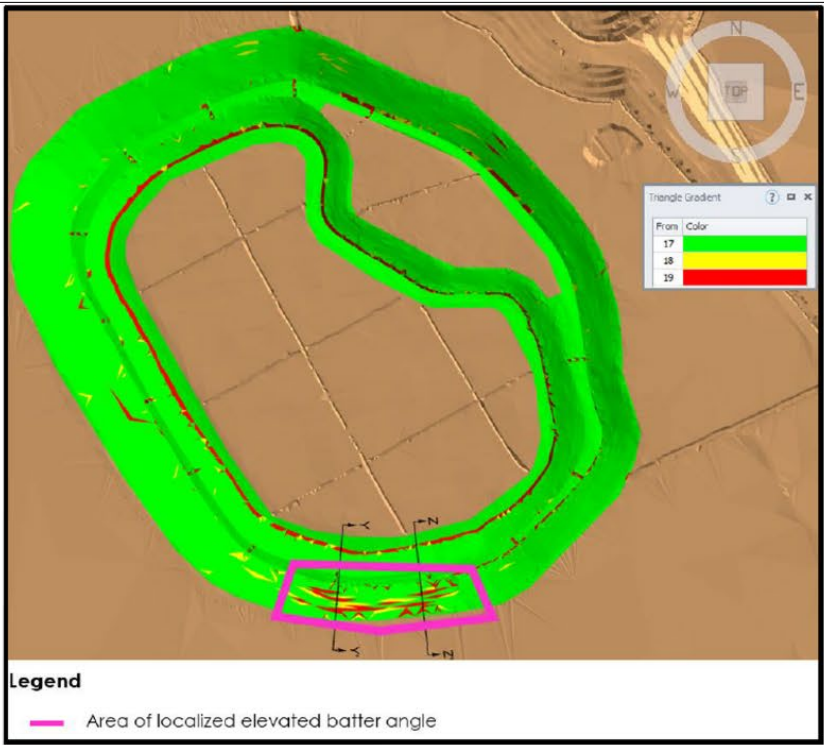
Figure 78 Aurora WRL – As-Built Design Assessment

Batter Gradient Assessment

The key gaps between the design and as built geometry relate to (Table 46 and Figure 78) (Okane Consultants, 2022b):

- The height is significantly less than design resulting in an increased footprint area (4 ha compared to planned footprint of 2.2 ha).
- Due to being constructed in a single lift there was no requirement to install the designed berm.

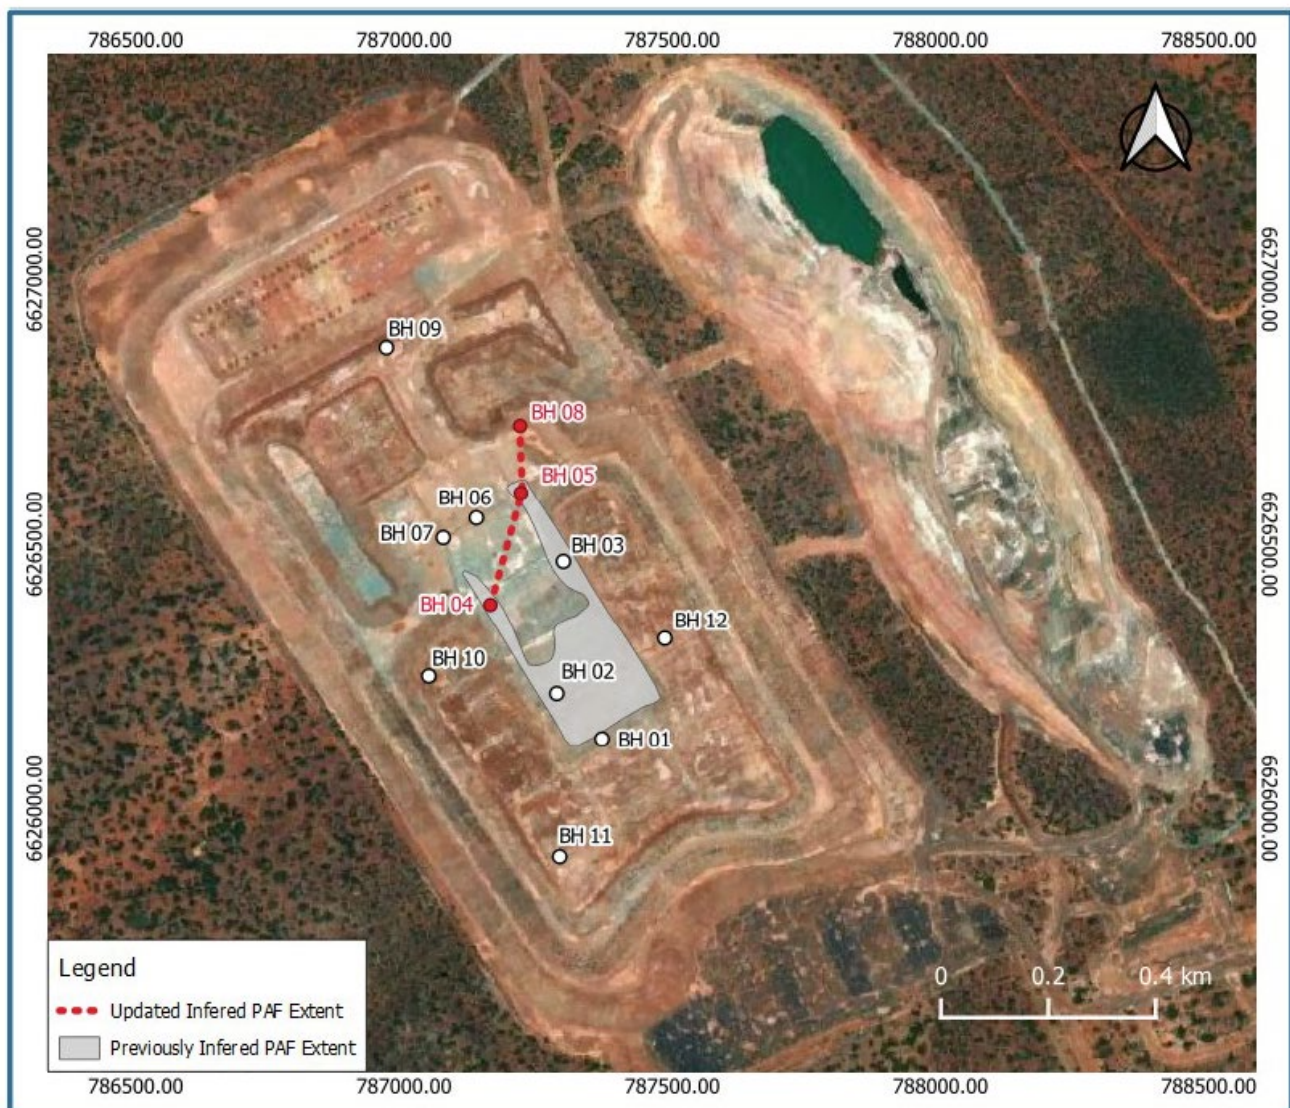
**Figure 81 PAF Cell Extent Based on Drilling Results**

- PAF has been encapsulated within the Carina WRL, but that lateral extent of the PAF material differs from the inferred PAF cell (Figure 81).
- The volume encapsulated was less than originally planned.
- In the area intersected by drillholes BH04 and BH05, the PAF encapsulation cover just meets the 2 m minimum capping design criteria.
- The extent of the PAF cell to the north east is undefined but the material intersected at BH08 is considered low risk due to the 11 m of NAF cover present (Okane Consultants, 2023b).

- All but one of the samples classified as PAF or Uncertain in Figure 82 and Figure 83 were within the inferred PAF cell. One sample (BH08) was from outside the inferred PAF cell suggesting that the PAF cell may extend further to the north east (Figure 80).
- The samples classified as PAF were located between 475 mRL and 485 mRL. PAF material in BH04 and BH05 was within 2 – 2.4 m of the WRL surface (i.e., at the limit of the minimum 2 m

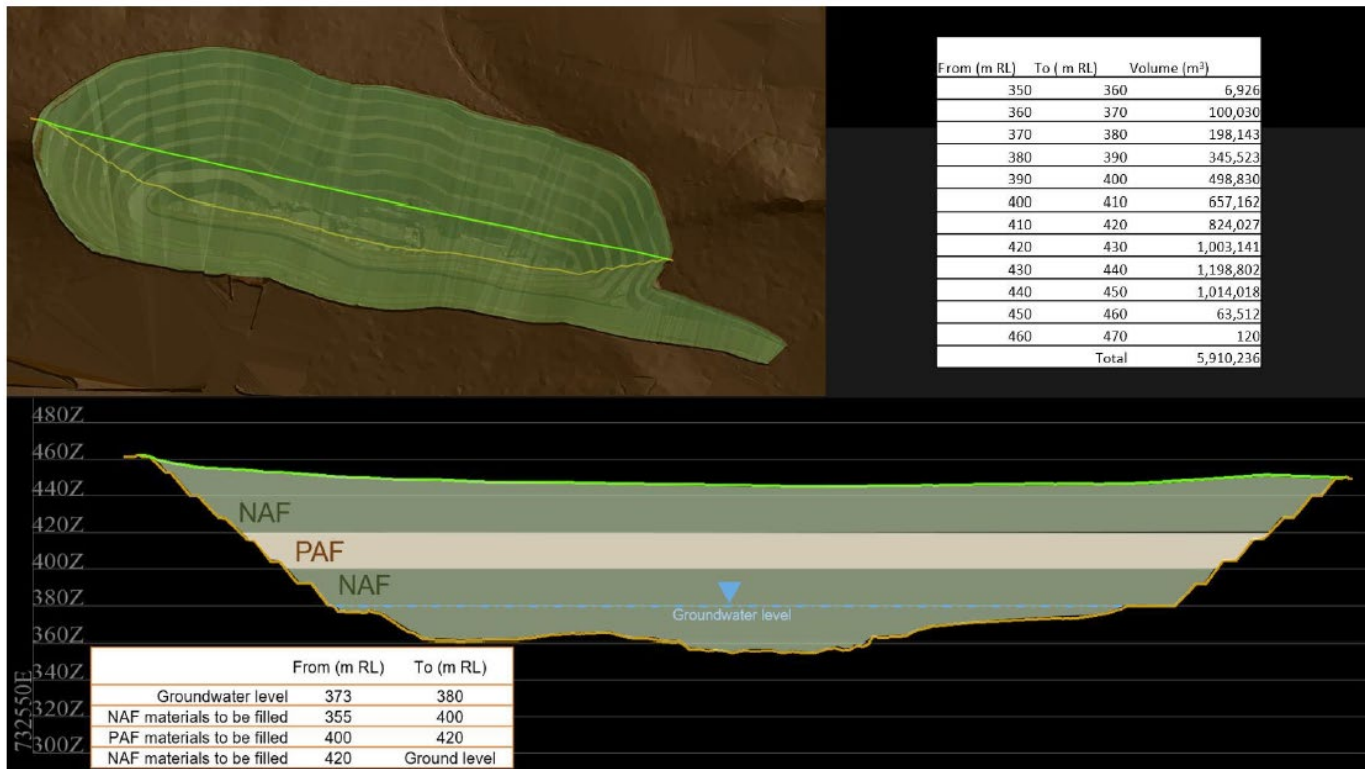
**Figure 92 J4 West Backfill – PAF Management**

- The pit will be backfilled with non-dispersive and NAF material to approximately 20 m above known groundwater level (~ 380 m AHD), i.e., to 400 m AHD.
- PAF material will be deposited between 400 m AHD and ~ 420 m AHD.
- PAF material will be covered with a 20 m layer of non-dispersive and NAF waste material to surface level ~ 460 m AHD. The cover will be designed to minimise oxygen ingress and infiltration and be resistant to surface erosion.

Waste will be deposited into the pit by haul truck and compacted. Limited settlement is expected; however, the area will be subject to inspections for 12 months following the completion of the backfill, prior to final contouring and placement of topsoil. Due to the relatively small surface area of the backfilled pit, and the outcome of backfilling the pit to natural surface levels and directing flows away from the surface of the backfilled area, surface water ponding is not anticipated to be significant (MinRes, 2023a).

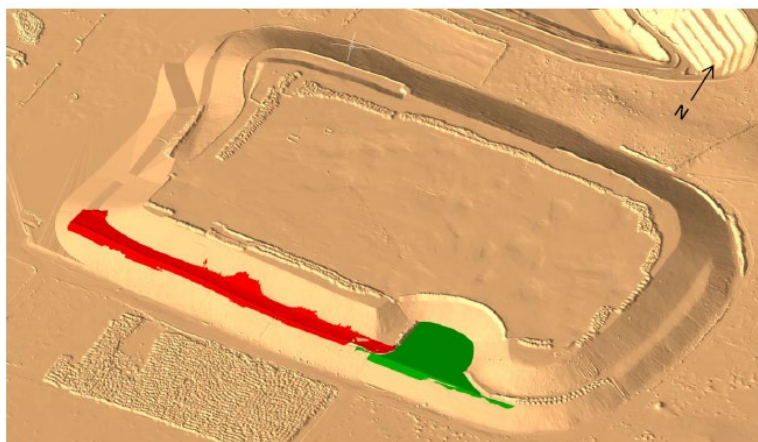
Figure 2 J4 East WRL stage 1 filling southeastern void lift 1, cut (red) and fill (green)

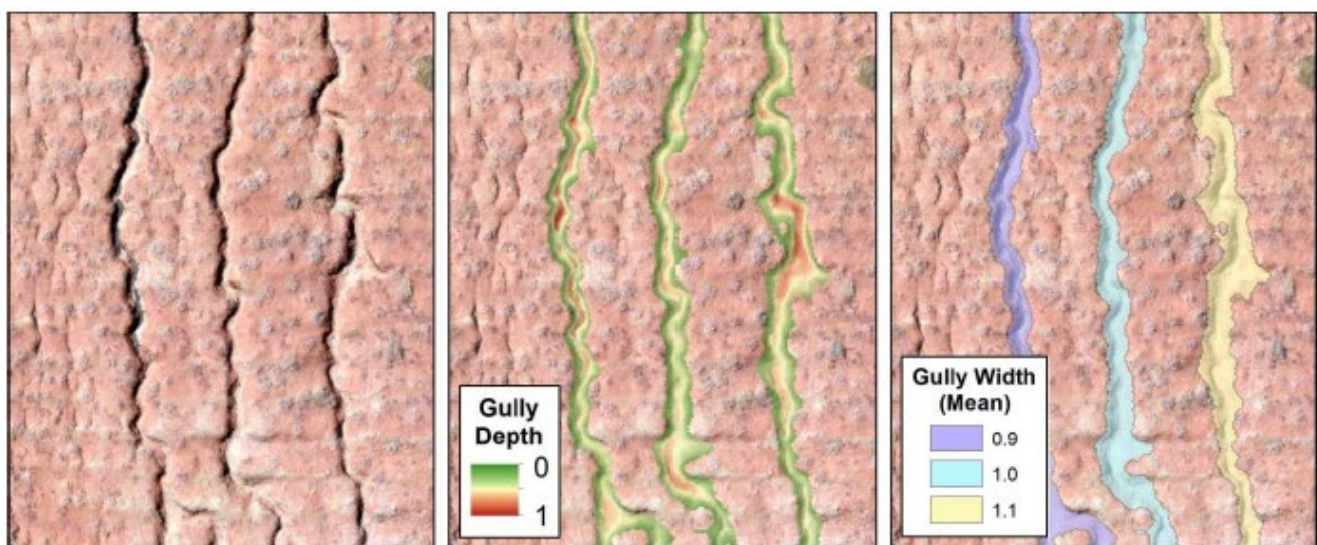
Figure 98 Illustration of gully depth and mean width

Evidence of erosion is also recorded during routine ground-based rehabilitation monitoring and conditions are recorded as described in Table 64.

The results will be plotted over time and assessed against data on climate, surface materials, landform geometry and vegetation establishment to inform closure strategies, rectification or maintenance requirements and to demonstrate performance against completion criteria.

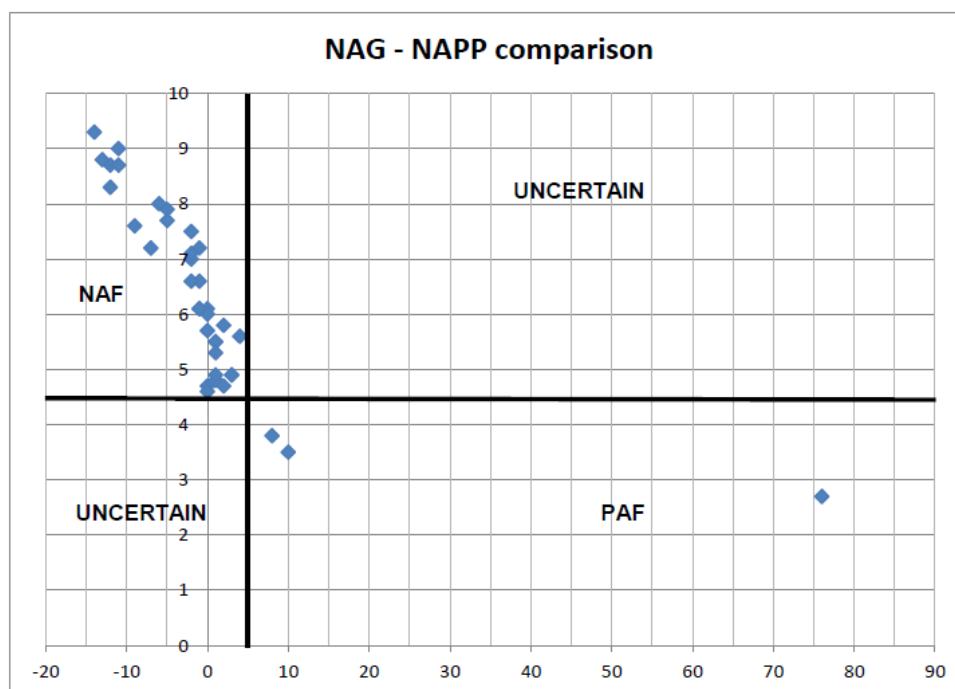
Geochemical classification of the waste types at Carina Extended is illustrated in Figure D.1 (based on static testing results from Table D.7) and summarised by lithology in Table D.6.

Note: Sample CXRC0007 (at 930 kg H<sub>2</sub>SO<sub>4</sub>/t) is omitted as including it compressed the graph axis which caused clarity on other results to be lost.

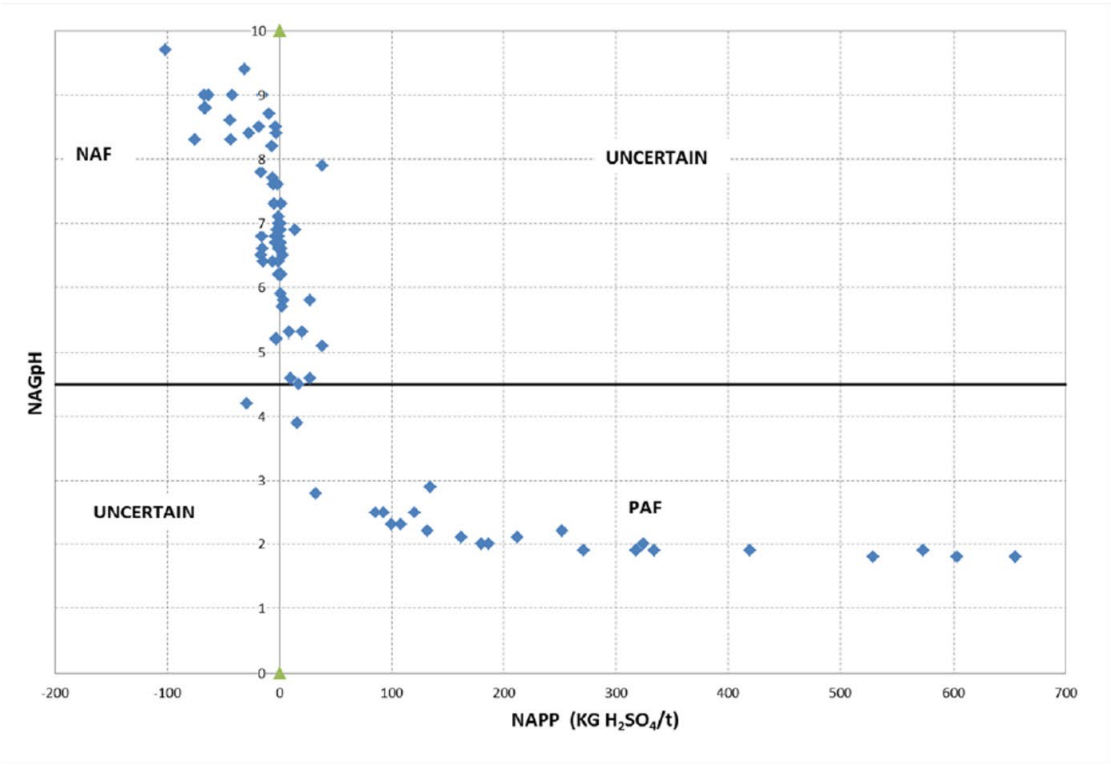
Preliminary (2013) geochemical classification

Subsequent testing of 20 composite sample also showed that the majority of samples (7 out of 8) from the upper 100 m of the profile were NAF (or UC in the case of clay samples), whilst the majority of the samples (10 out of 12) from below 100 m in the profile reported a classification of PAF.

Post-mining review of the data found that of the 103 samples assessed prior to mining, 24 samples were from drill hole intervals within the mined volume from J4 East and West pits. These in-pit samples were predominantly NAF (15 samples) or UC (NAF), with one PAF-LC sample (Table D.10 and Figure D-2. (SRK, 2023). The sulfur contents of the in-pit NAF samples range from 0.01-0.09% S, whereas the UC (NAF) (0.04–1.47% S) and PAF-LC (0.33%S) classed samples had higher sulfur contents. SRK (2023) concluded that based on the limited dataset of samples within the pit volumes, and the sulfur distribution of these samples, there is insufficient data to verify a robust sulfur cut-off value, however it was noted that the PAF-LC sample would be flagged OAW based on sulfur content.
