# **MINE CLOSURE PLAN**

## **CARINA OPERATIONS REV 1.0**

**30 APRIL 2024 VERSION 0**

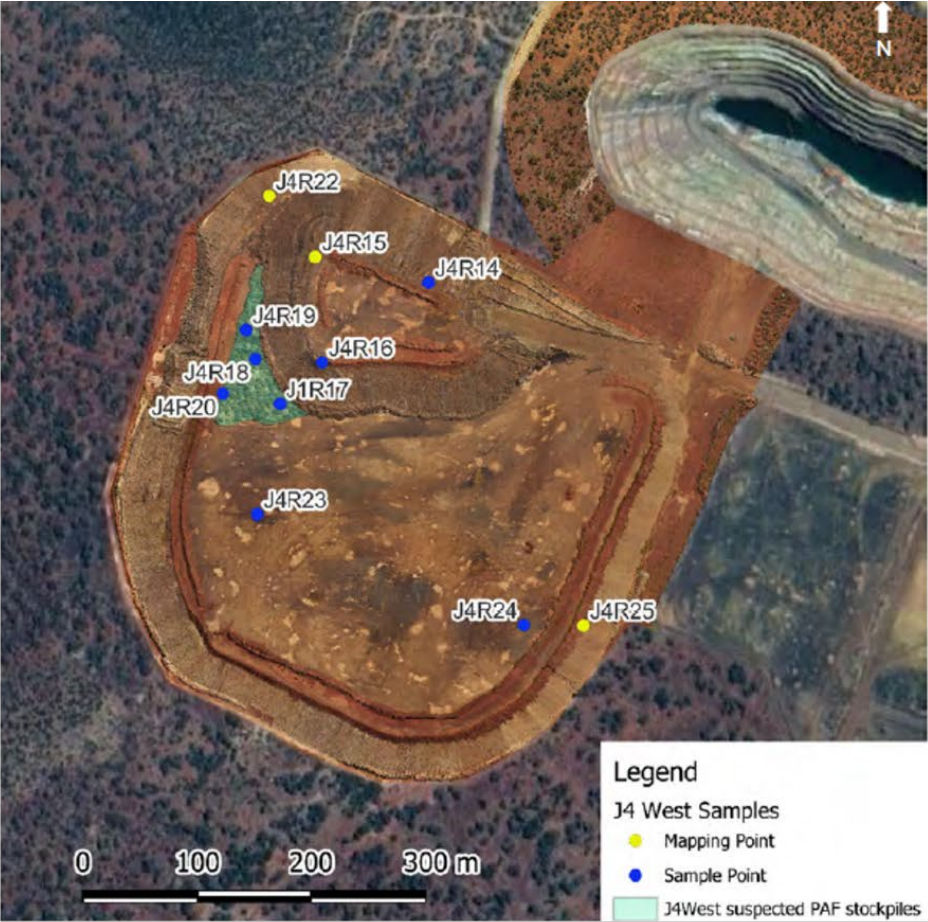
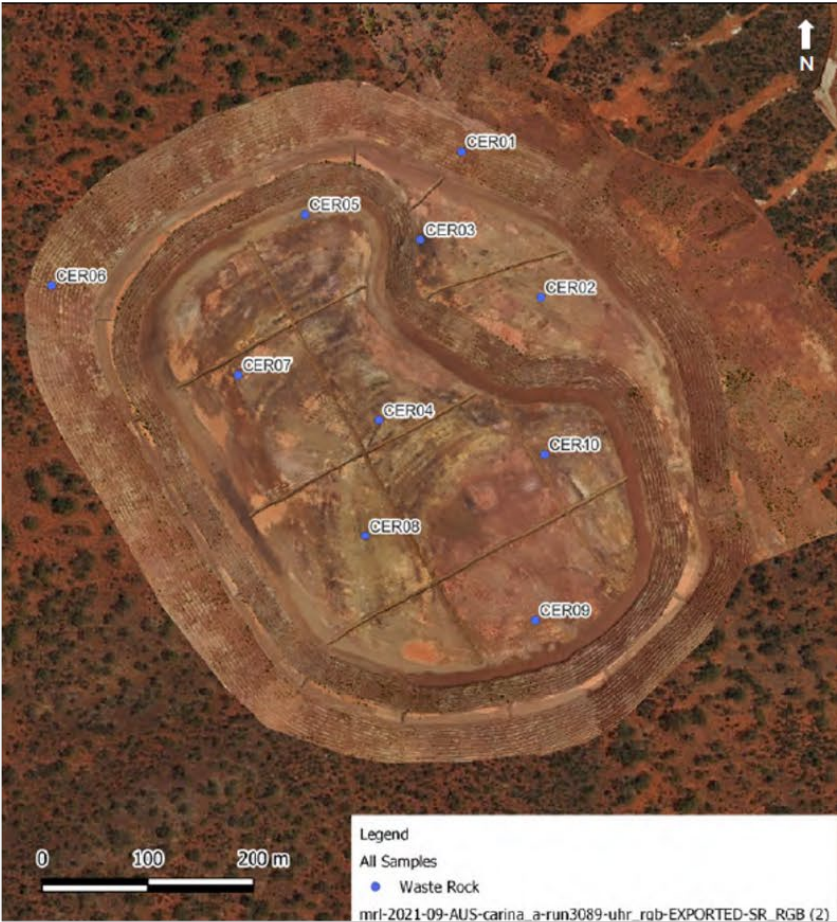
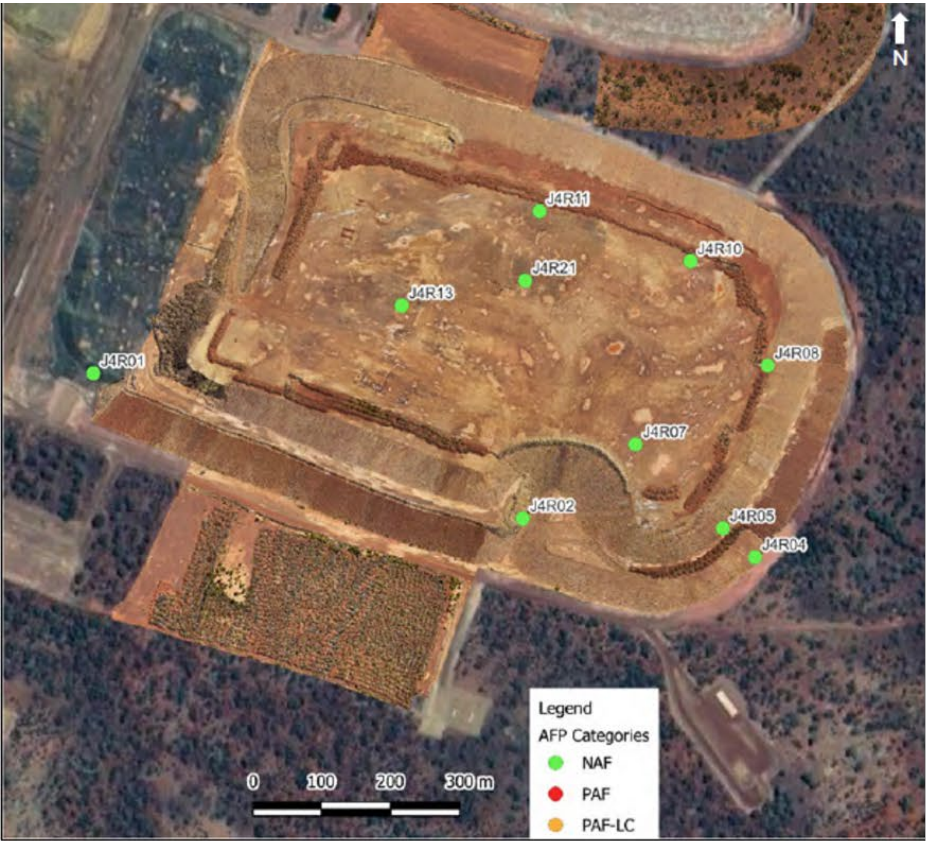
Figure D.7: WRL Waste Rock Surface Cover Characterisation – Sample Locations

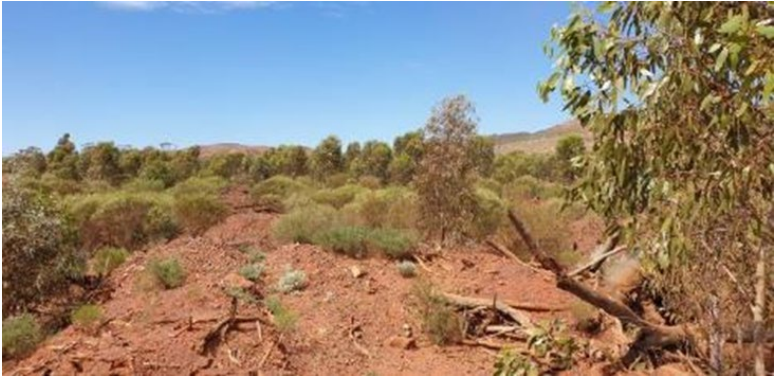
| Rating | Description | Example |
|---|---|---|
| Excellent | <ul style="list-style-type: none"><li>• Very high (+ 75%) vegetation cover.</li><li>• Diverse range of species present and evidence of self-seeding.</li><li>• High timber / vegetation content.</li><li>• Soil is good quality, contains a variety of particle sizes including gravel and rocks, not prone to erosion.</li><li>• All stockpiles are to a maximum 2 m in height.</li><li>• No weeds present.</li><li>• No evidence of erosion.</li><li>• No evidence of contact by saline water.</li></ul> | |

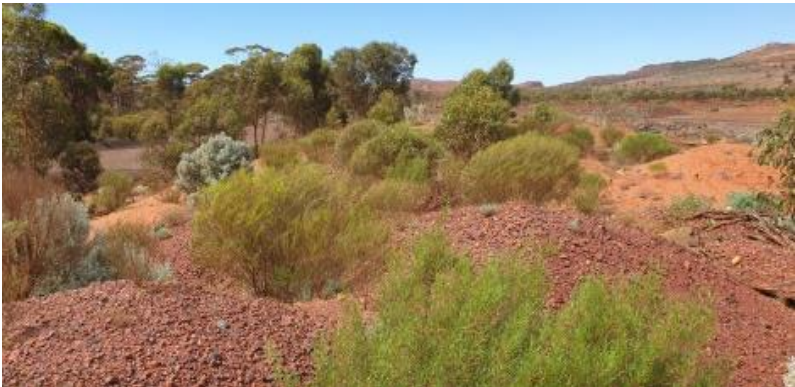
| Rating | Description | Example |
|---|---|---|
| Good | <ul style="list-style-type: none"><li>• 50% to &lt; 75% vegetation cover.</li><li>• Reasonable species diversity.</li><li>• Some timber / vegetation content.</li><li>• Most soil is good quality.</li><li>• All stockpiles are to a maximum 2 m in height.</li><li>• No weeds present.</li><li>• Minimal evidence of erosion.</li><li>• No evidence of contact by saline water.</li></ul> | |

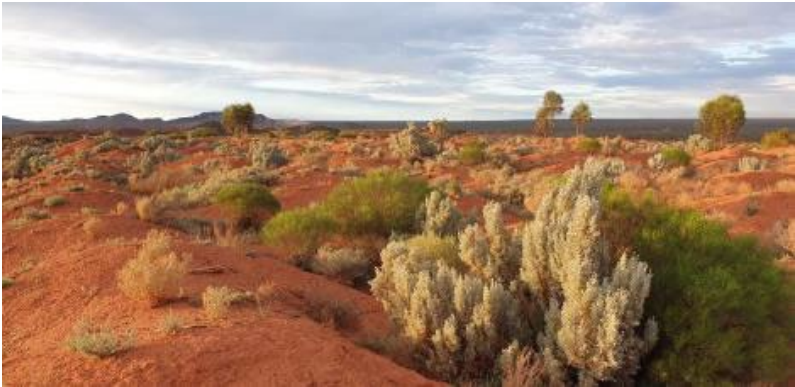
| Rating | Description | Example |
|---|---|---|
| Moderate | <ul style="list-style-type: none"><li>• 25% to &lt; 50% vegetation cover.</li><li>• Dominated by a few species. Weeds may be present.</li><li>• Minimal timber / vegetation mixed with the soil.</li><li>• Some stockpiles exceed the recommended 2 m height.</li><li>• Soil has poor structure (i.e., sodic and / or prone to becoming "bulldust").</li><li>• May be some contact with saline water.</li></ul> | |

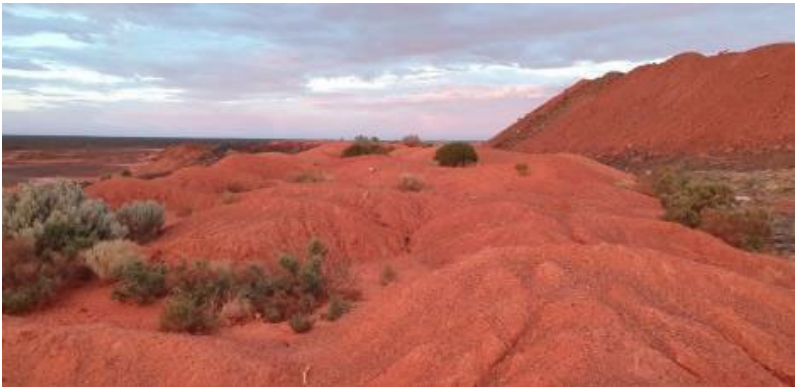
| Rating | Description | Example |
|---|---|---|
| Poor | <ul style="list-style-type: none"><li>• &lt; 25% vegetative cover, dominated by one or two species (i.e., <i>Maireana brevifolia</i>, <i>Atriplex</i> spp).</li><li>• Weeds present.</li><li>• Little or no timber / vegetation mixed with the soil.</li><li>• Most stockpiles exceed the recommended 2 m height.</li><li>• Soil has poor structure and is prone to, or impacted by, erosion.</li><li>• Evidence of contact with saline water.</li></ul> | |
