# CARINA J4 PROJECT ENVIRONMENTAL MANAGEMENT PLAN 2023-2025 IMPLEMENTATION REPORT

**MINISTERIAL STATEMENT 852-  
957 & 988**

25 FEBRUARY 2025 - VERSION 00

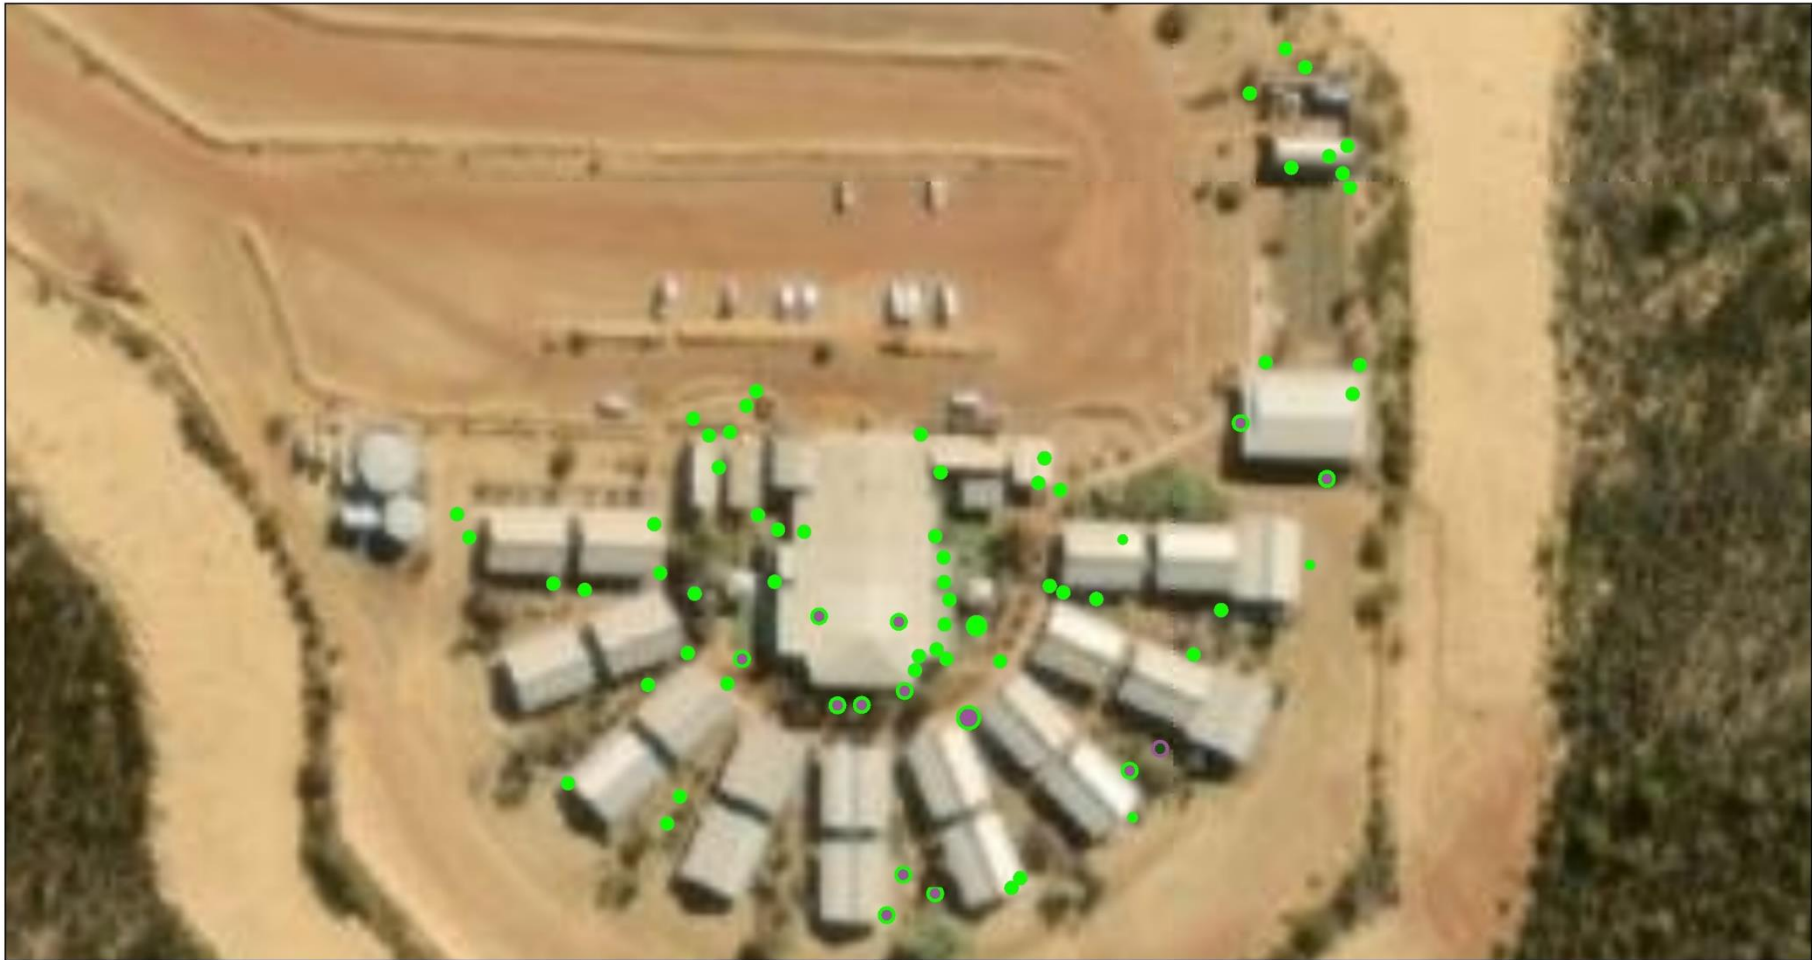
08/01/2024  
Carina Camp

- Weed Species
- Sonchus spp
  - Conyza bonariensis, Sonchus spp
  - Arctotheca calendula, conyza bonariensis

- Weed Abundance
- <10
  - <100
  - >500
  - >1000

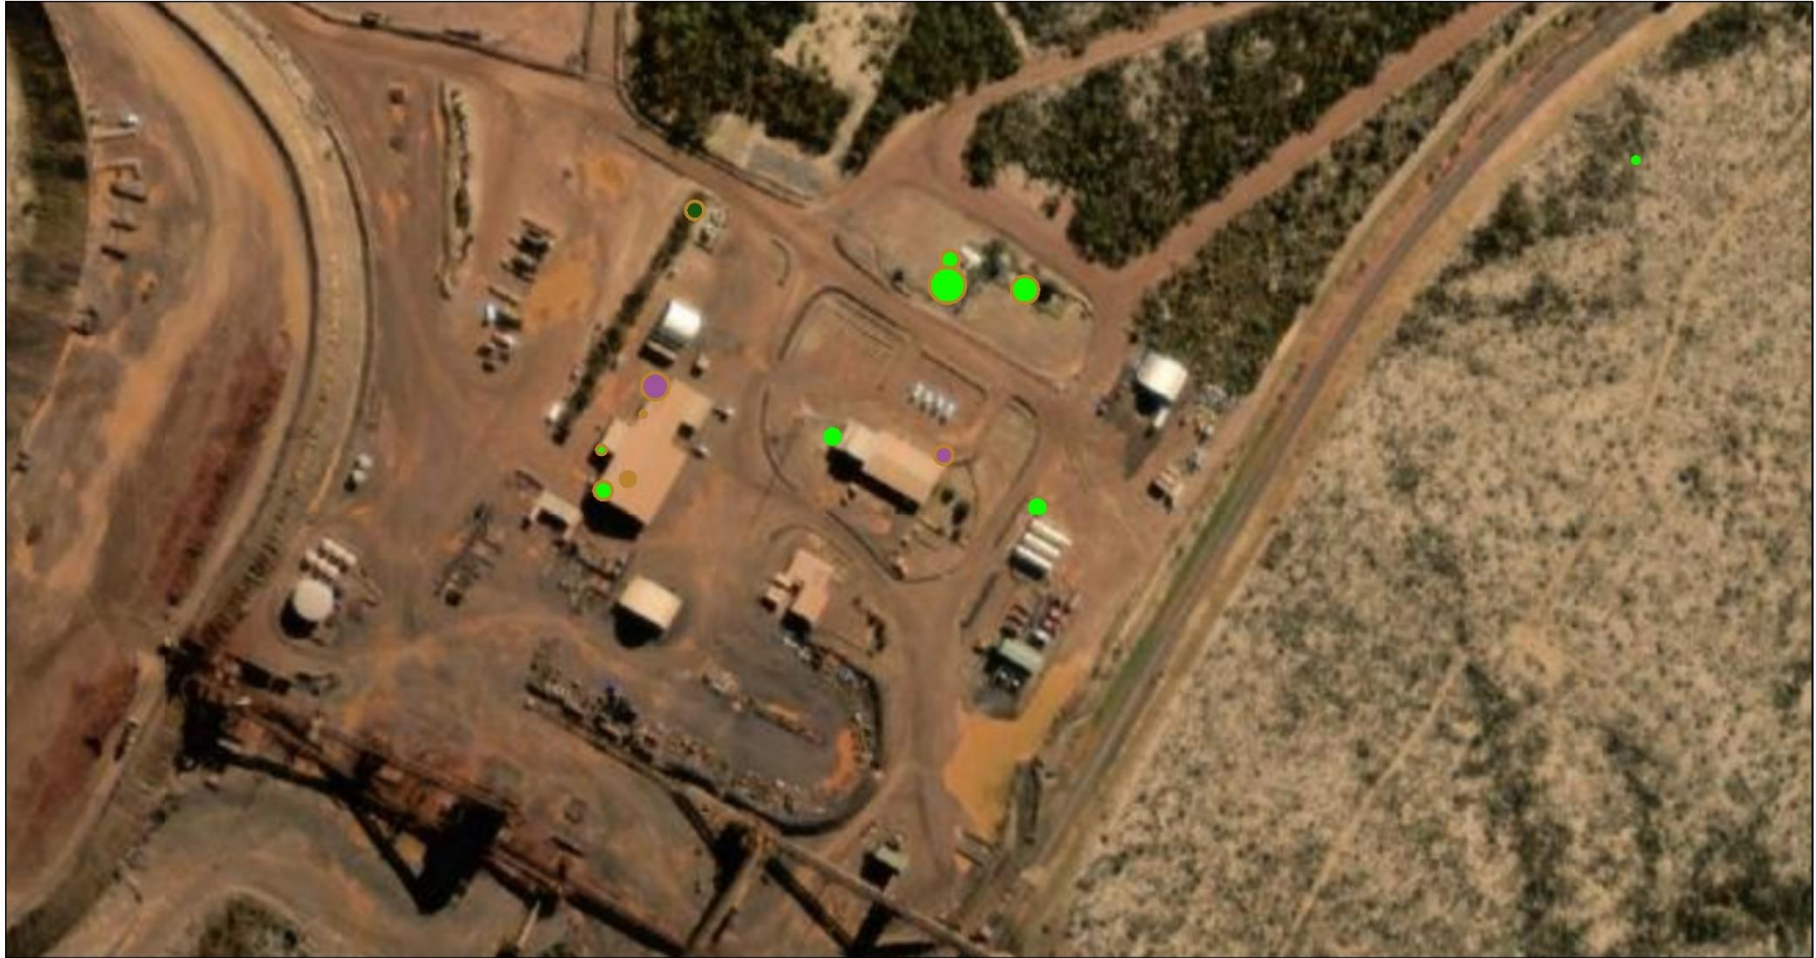
Carina CSI & ROM

08/01/2024

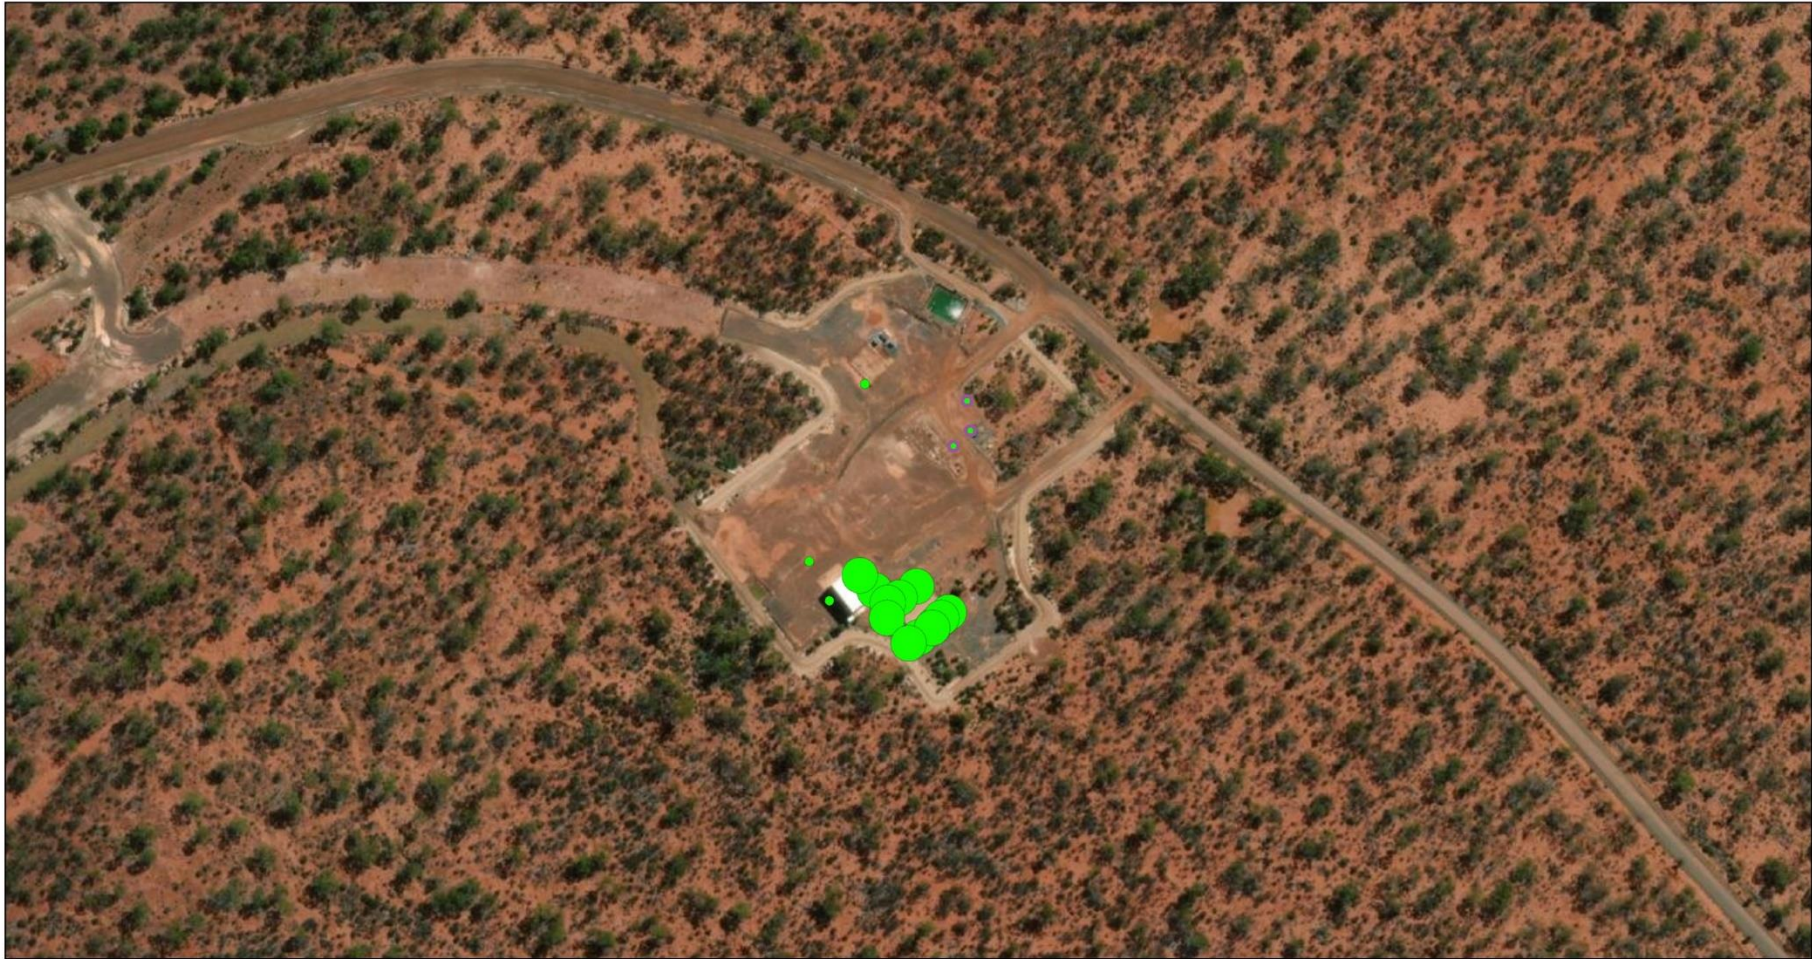
Carina Southern Operations Yard

08/01/2024

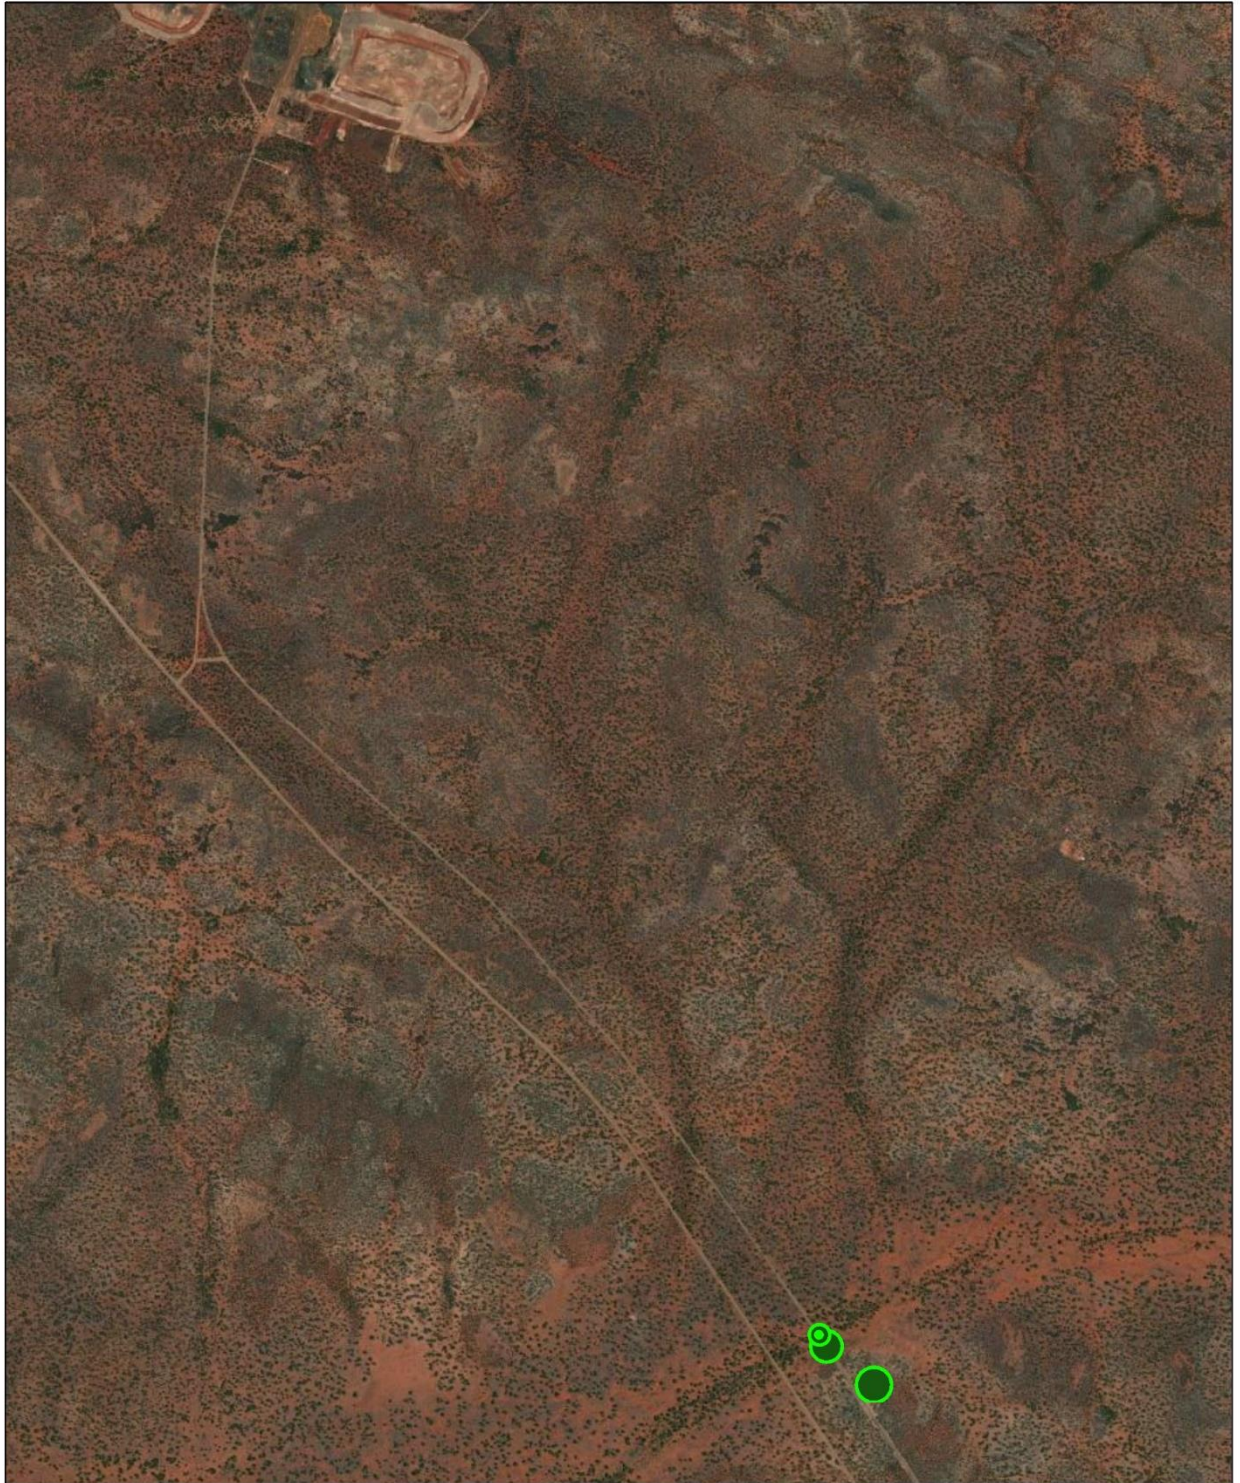
J4 Haul Rd

- <50
- <100
- >100

08/01/2024

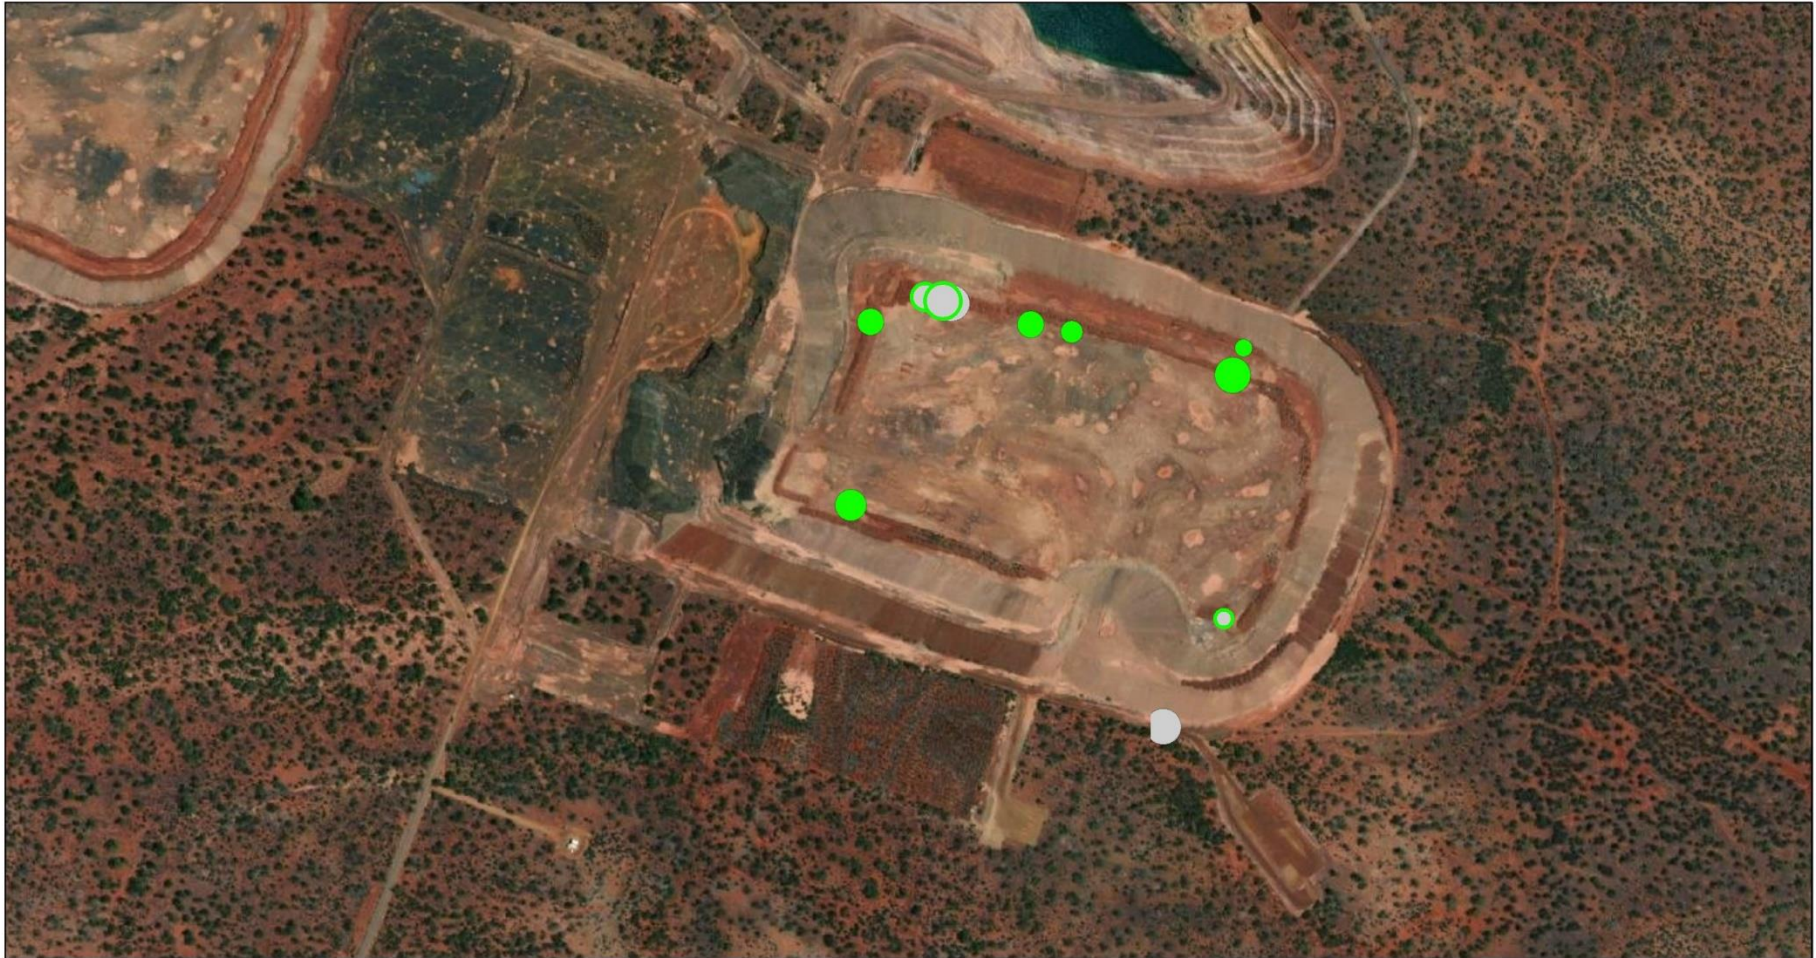
J4 WRD E

08/01/2024

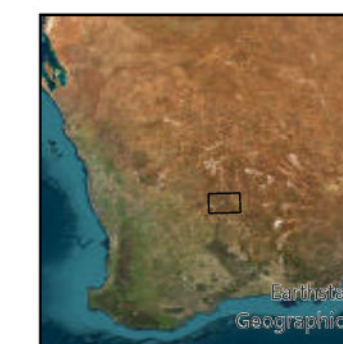
*Phytophthora* Dieback occurrence as at August, 2023. Recheck required from August, 2024.  
PDI Jeremy Spencer. Registration No. DPW PD018

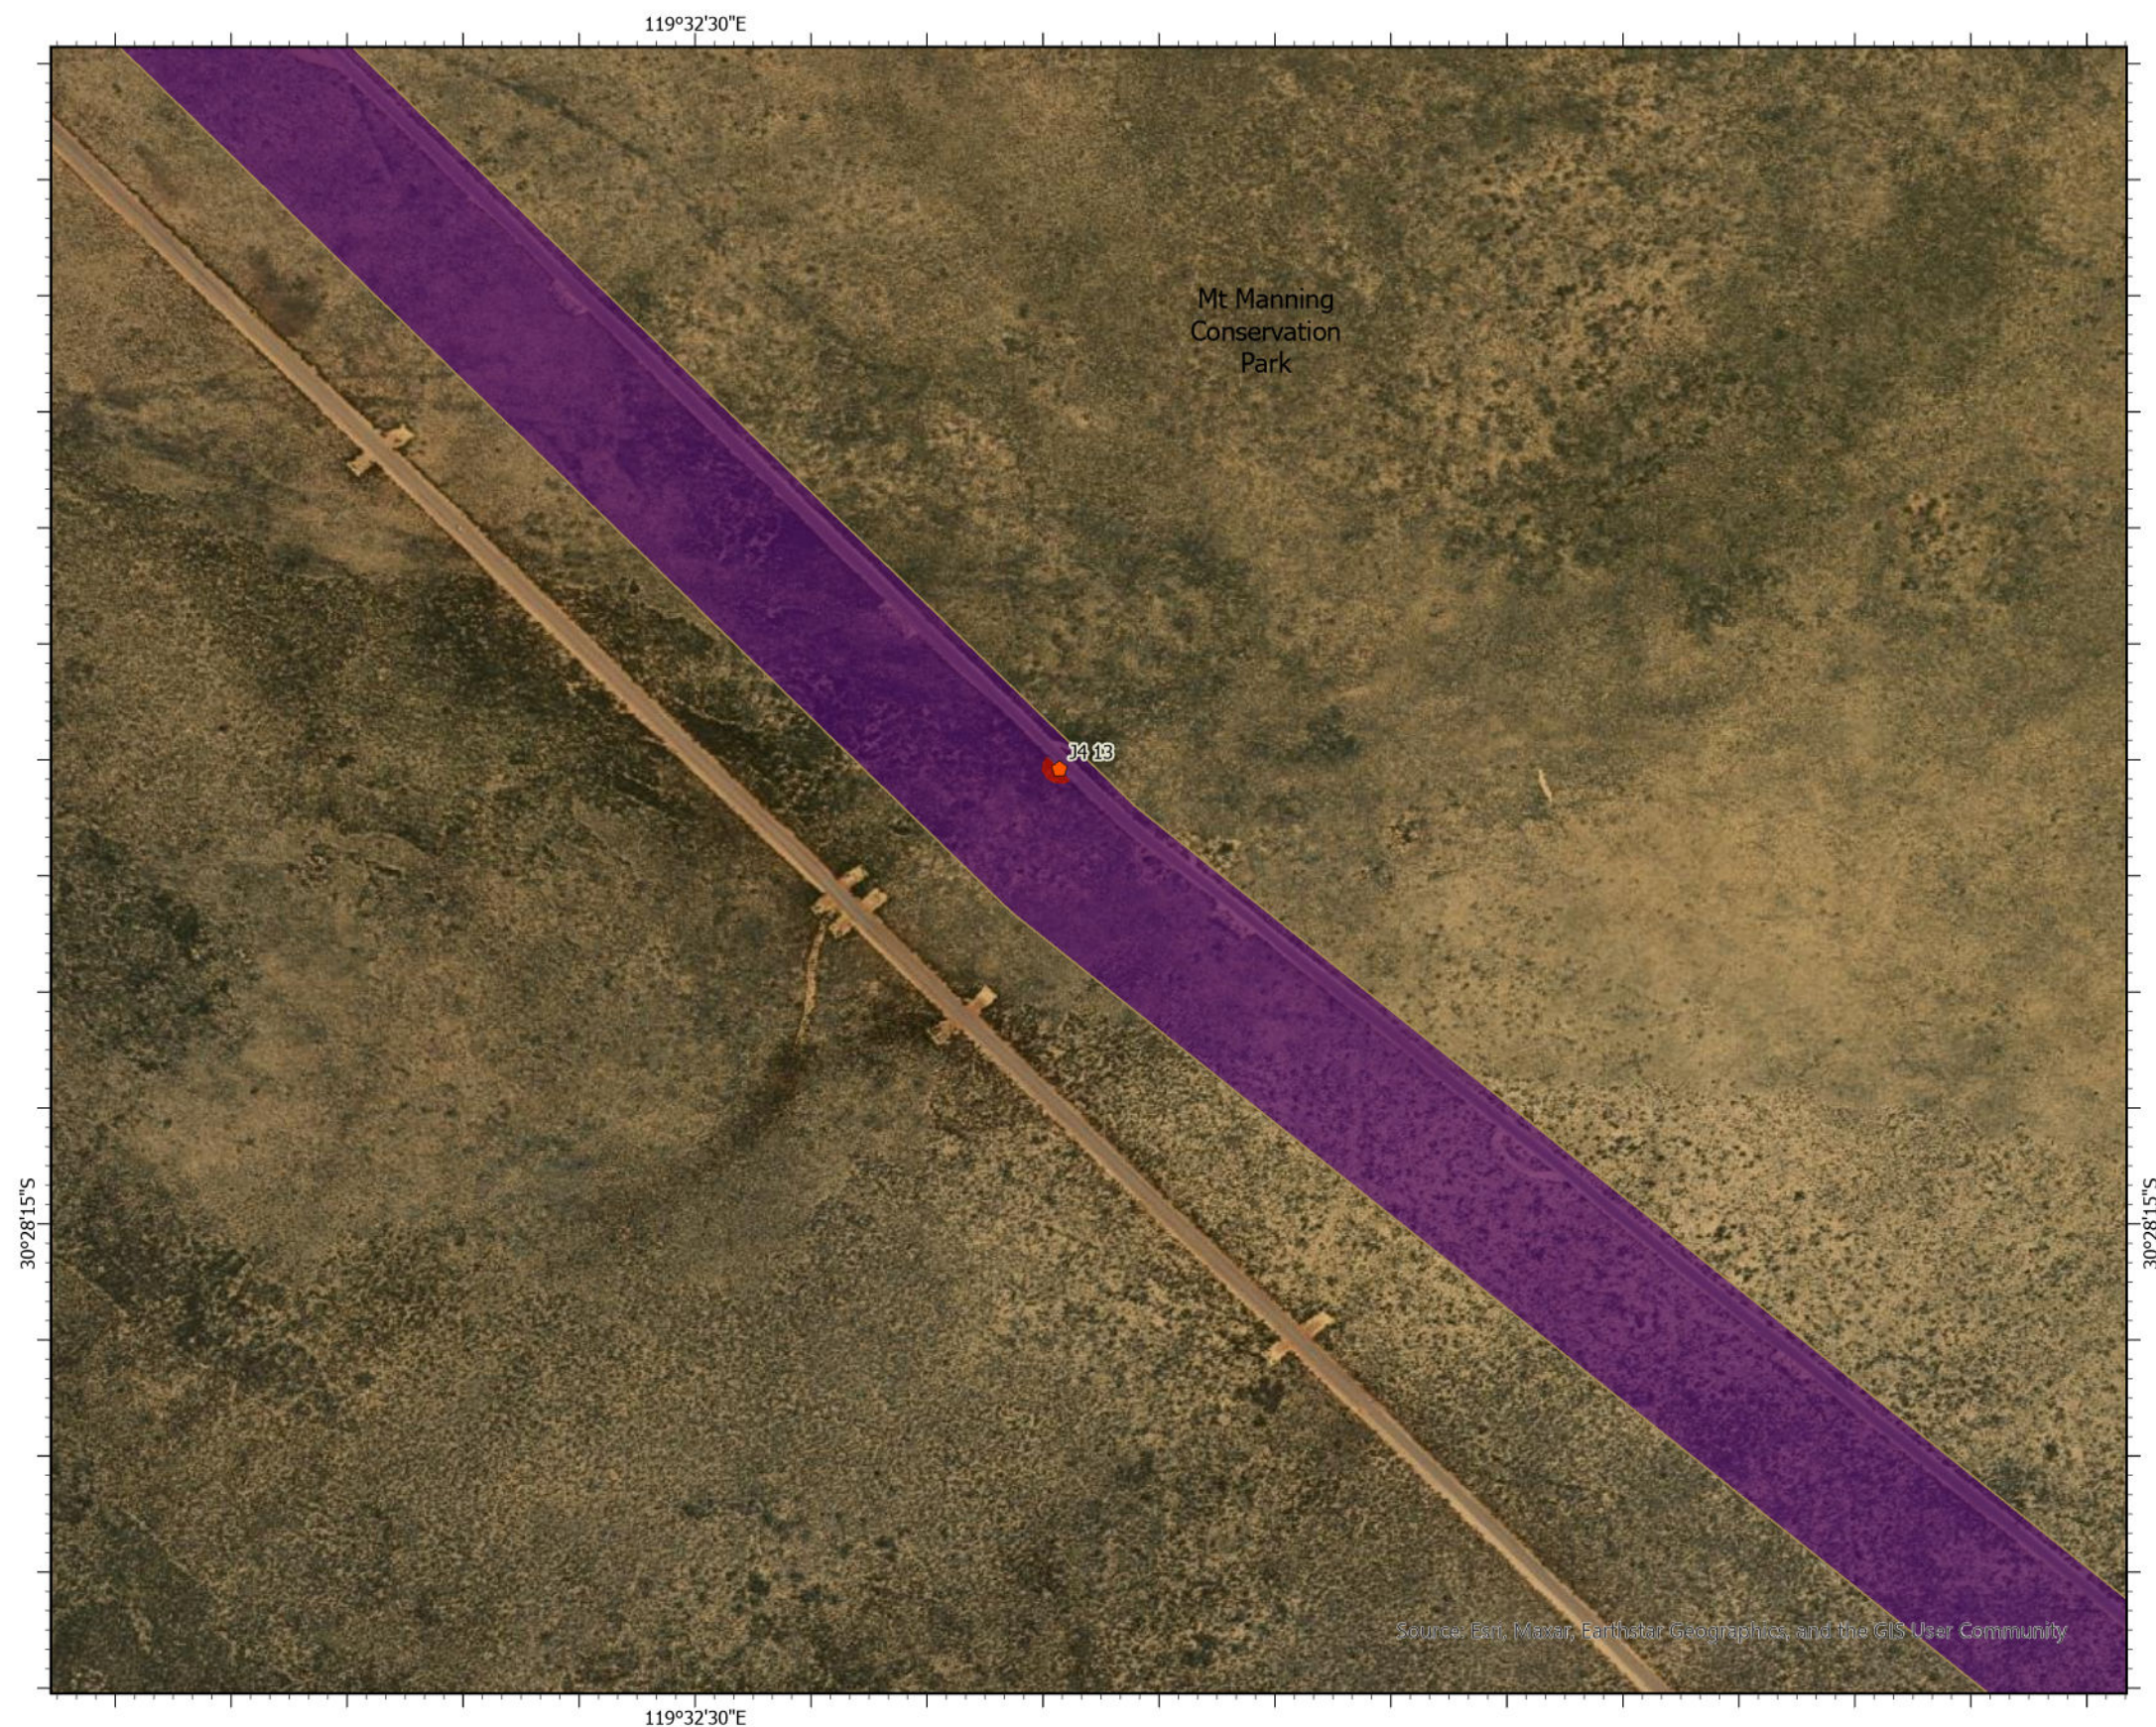
Figure 2-1 Phytophthora Dieback Occurrence showing Sample Locations and Results

### Dieback Status

- Infested
- Uninterpretable

Phytophthora Dieback occurrence as at August 2023. Recheck required from August, 2024.  
PDI Jeremy Spencer. Registration No. DPW PD018

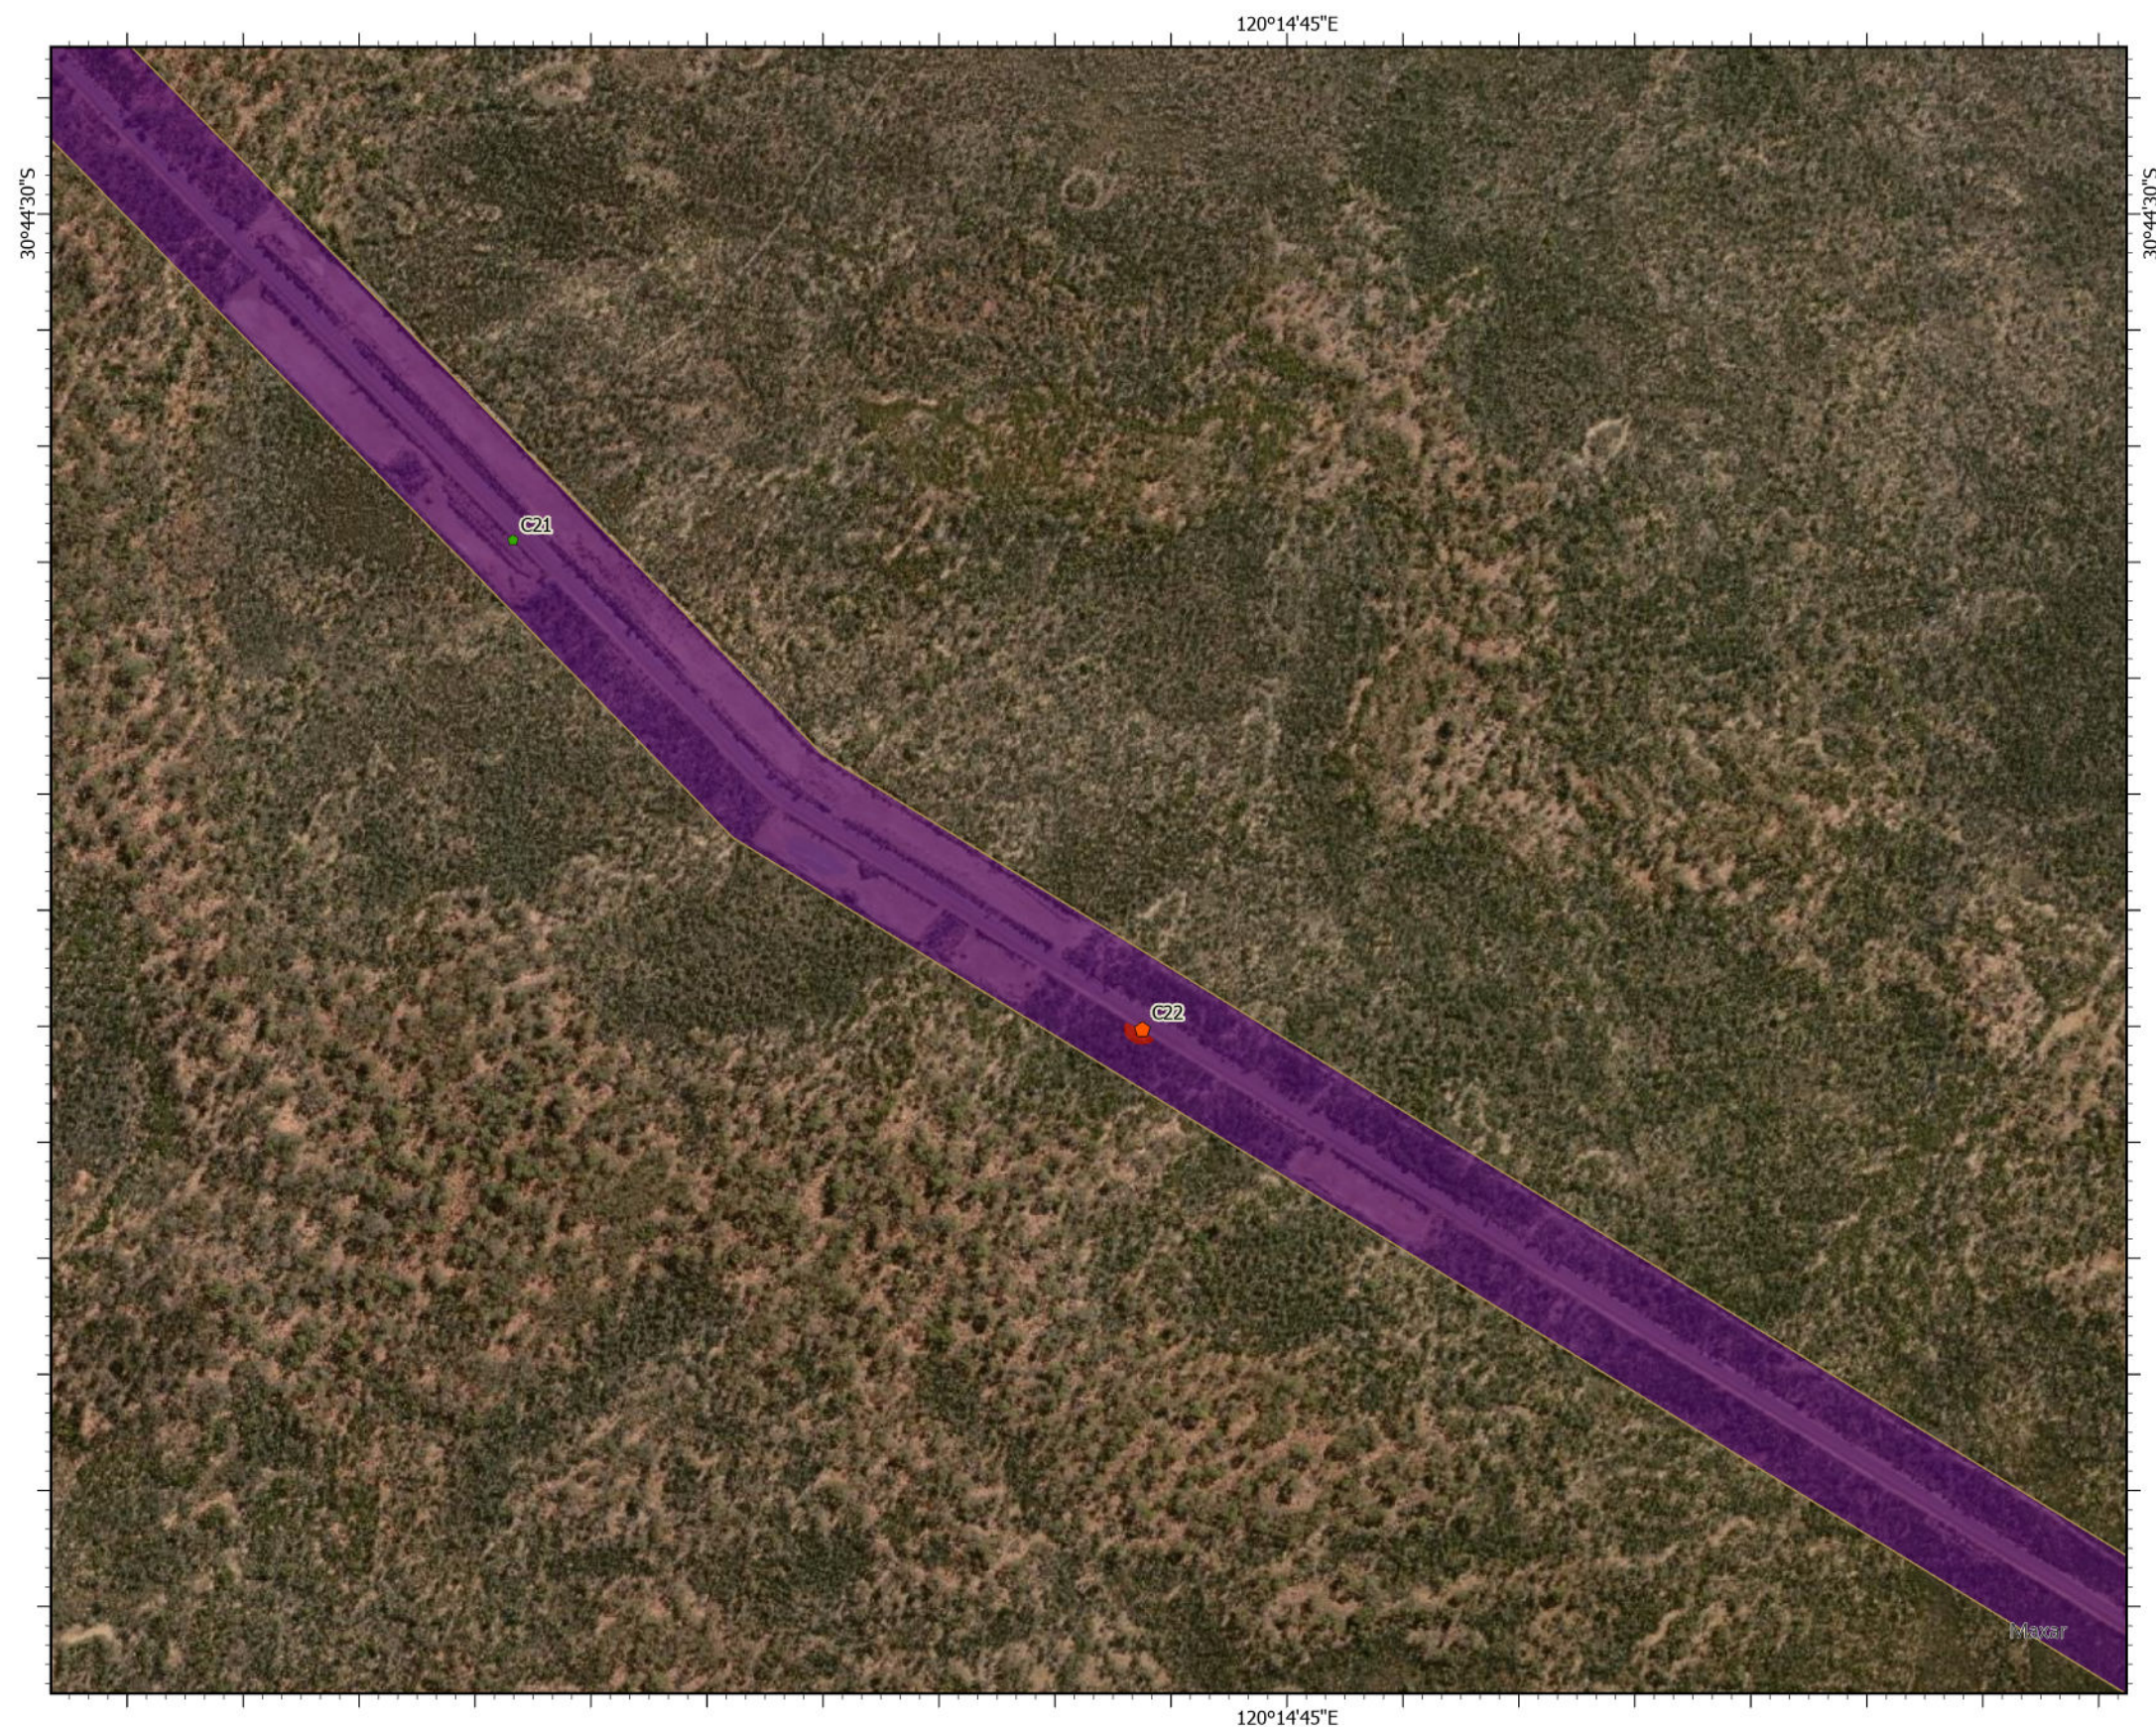
Figure 2-4 Phytophthora Dieback Occurrence showing Sample Locations and Results

### Dieback Status

- Infested
- Uninterpretable

Phytophthora Dieback occurrence as at August 2023. Recheck required from August, 2024.  
PDI Jeremy Spencer. Registration No. DPW PD018

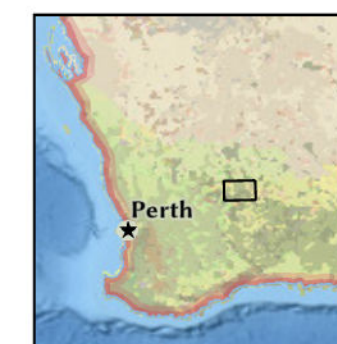
Phytophthora Dieback occurrence as at June 2024.  
Recheck required from June, 2025.  
PDI Jeremy Spencer. Registration No. DPW PD018
